SINKHOLES: The Hole Story ...Issues are Deeper than you Think!

Technical Note

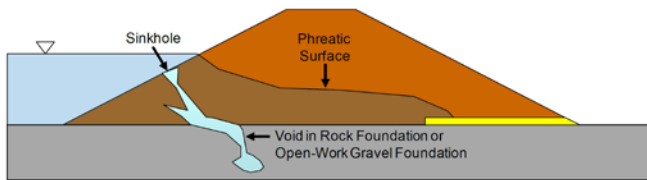
Figure 1: Sinkhole formation (from Reclamation Best Practices Fig 26-3a)

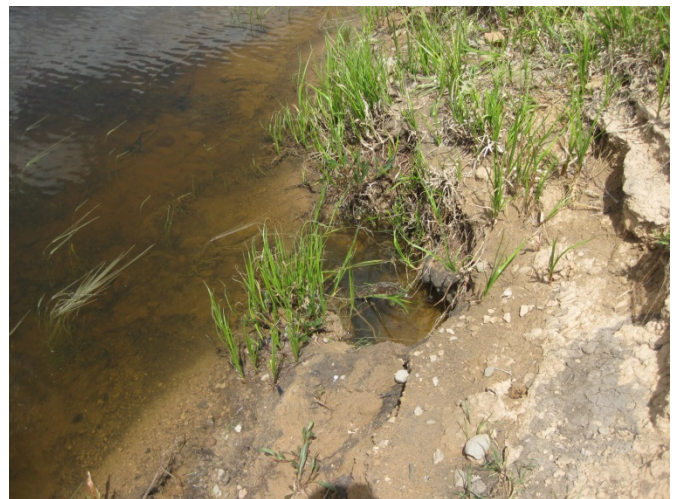
Photo 1: Example of small depression that may go unnoticed (Young Creek Dam)

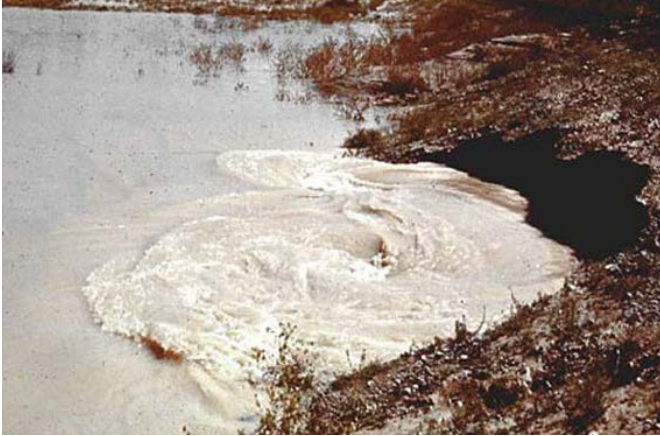
Sinkholes can often be identified by whirlpools forming upstream of the dam. Whirlpools may be significant and easily observable (Photo 2), or they may be slight enough that they simply result in leaves or grasses floating in a circular pattern, which is the more common scenario.

Photo 2: Whirlpool upstream of dam (U.S Forest Service)

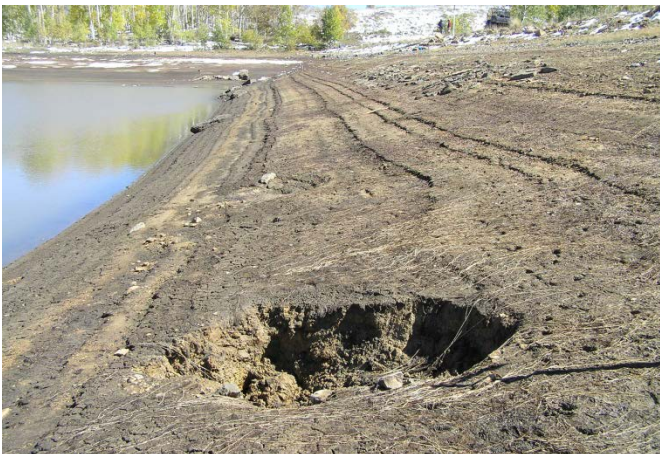
Photo 3: Sinkhole on upstream embankment (Paxton Dam)

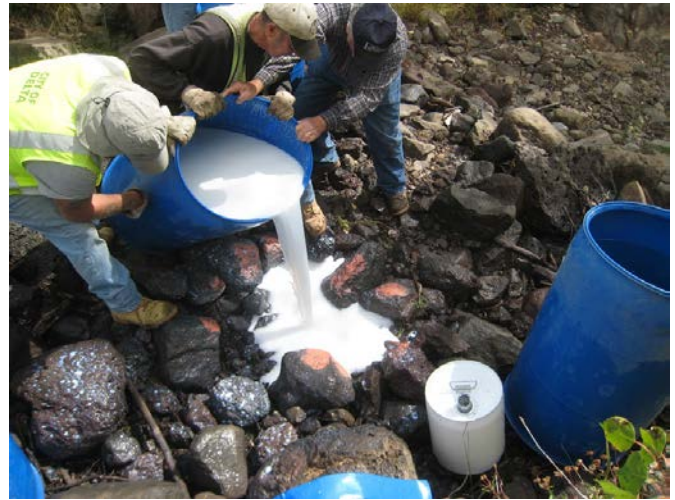
Photo 4: Application of chemical urethane grout (Big Battlement Dam)

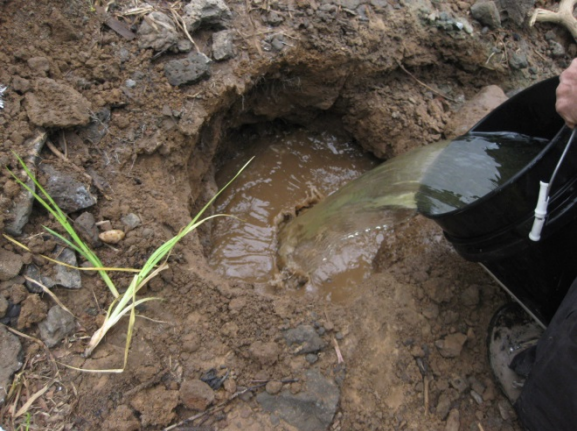
Fish Lake, CO –This dam has a history of seepage along the downstream toe, believed to be due to the open matrix character of the foundation rock. A sinkhole recently occurred on the upstream side of the dam near the left abutment, presumably due to voids most likely at the interface between the dam embankment and the foundation. The sinkhole was first observed during a routine inspection in July 2011. Further inspection and dye testing by a geotechnical engineer in October 2011 confirmed the location of the entrance and exit point of the seepage flowing from the toe of the embankment. The use of urethane grout was recommended to fill the sinkhole. Grouting took place in August 2012.

Photo 5: Flushing of sinkhole at Fish Lake, CO

The sinkhole was first cleared of rock and debris and then flushed with approximately 5 gallons of water to obtain thorough pre-wetting for the grout application.

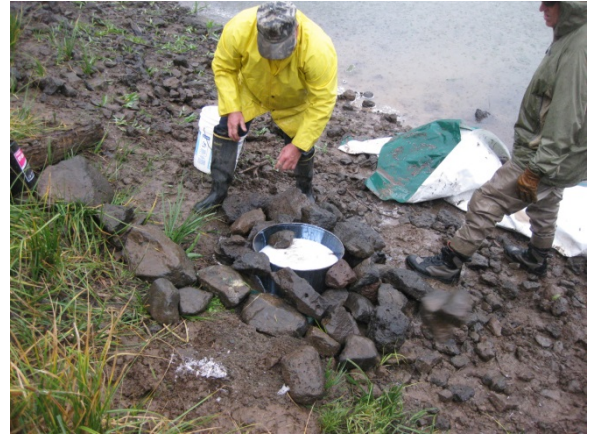
Photo 6: Final application of grout, contained within pipe (Fish Lake)

The application of the grout into the sinkhole was aided by a steel pipe and tarp to funnel the material. Stratathane ST-504 Vari-Gel Injection resin was used. Lake water was used for flushing and mixing the grout. The grout was applied in stages with three different mixes, becoming more viscous with each application. The mixes were:

- 15 water to 1 grout: 30 gallons of water applied, grout completely absorbed, poured easily.

- 10 water to 1 grout: 30 gallons of water applied, grout completely absorbed, some backing up during pouring.
- 5 water to 1 grout: 5 gallons of water applied, grout was not entirely absorbed, pipe containment was half full.

The most fluid mixture took longer to set up before the next application could be poured, but obtained the greatest penetration into voids or cracks related to the sinkhole and seepage path. The second and third application took less time to set up but obtained less penetration. All mixtures expanded upon application and the last mixture served to cap the sinkhole. After the grout had set up and cured, the pipe was removed and the area was backfilled with rock to provide protection for the grout. An inspection 6 months after the grout application found some shrinkage of the grout at ground surface, but the sinkhole appeared to be sealed. No issues have been reported around the sinkhole or in other areas of the dam since the repair.

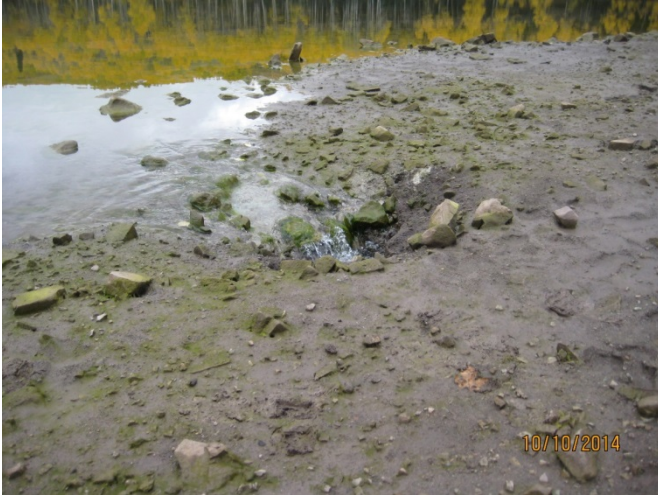
Lake Ann, CO – Seepage 400 feet downstream of the dam has been a longstanding issue at Lake Ann. Evidence indicates water was flowing through the foundation of the dam from upstream. A sinkhole from the 1960s was repaired with a plastic liner. Deteriorated plastic was found and removed in the excavation of a more recent sinkhole in the same area. The recent sinkhole was observed at the dam approximately 15 feet upstream of the intake and 100 feet right of the outlet. The flow was approximately 0.3 cubic feet per second when initially measured in October 2014. The reservoir was immediately drained

Photo 7: Sinkhole when first observed at Lake Ann, CO

to below the sinkhole to stop the flow of water through the sinkhole while repairs were developed and implemented.

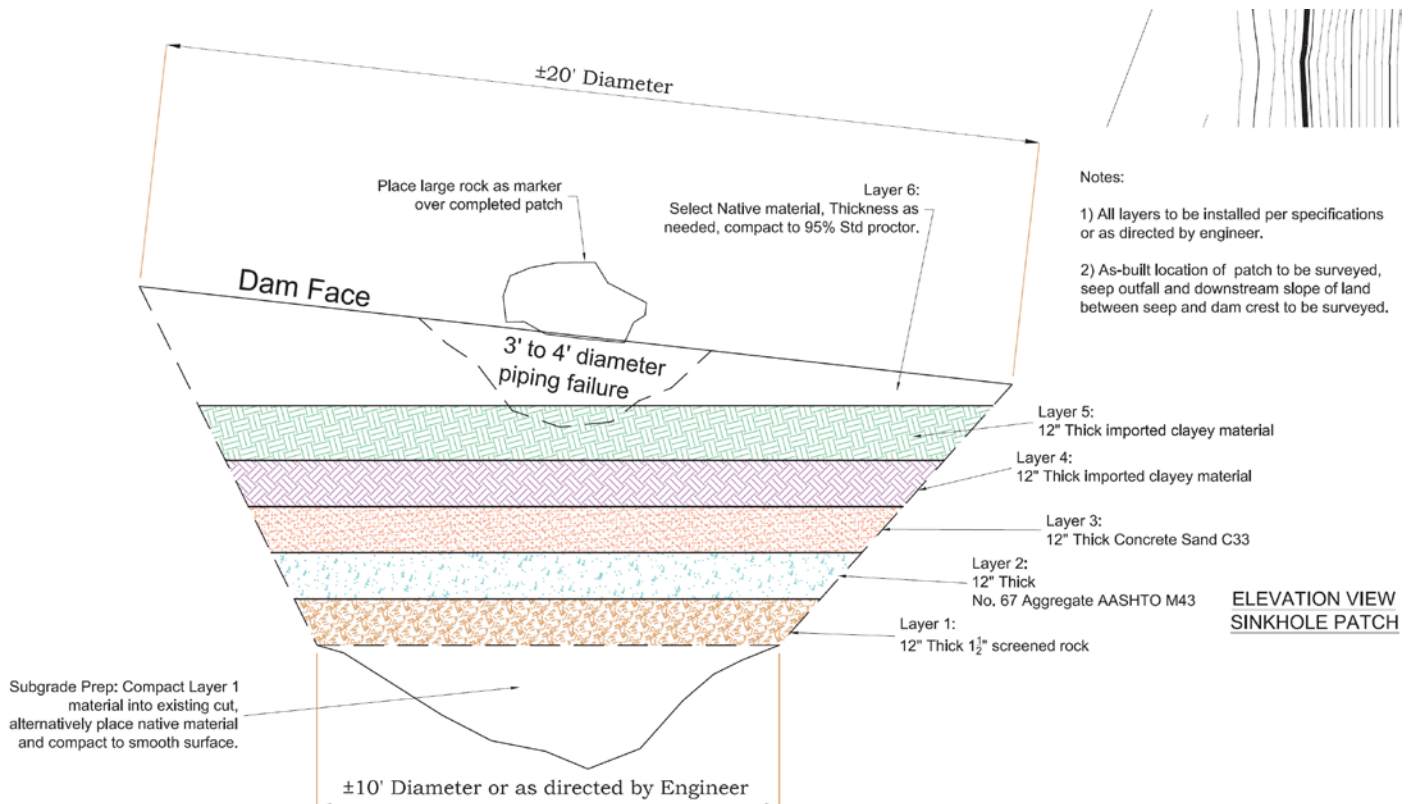
Figure 2: Elevation of sinkhole repair patch

A reverse filter was designed and constructed to repair the sinkhole. The sinkhole area was excavated to approximately 6 feet deep, 20 feet in diameter at the surface and 9.5 feet in diameter at the bottom. The subgrade was compacted before application of the filter material. The reverse filter was constructed of five layers, each 12 inches thick followed by a layer of native material at the surface. The properties of the five layers were as follows (Layer 1 was placed at the bottom of the excavation):

1. 1.5-inch screened rock
2. No. 67 Aggregate AASHTO M43
3. 50% C33 concrete sand and 50% 3/8 inch screened rock
4. Clayey material
5. Clayey material

(Layers 4 and 5 formed a two-foot thick compacted clay liner/cap).

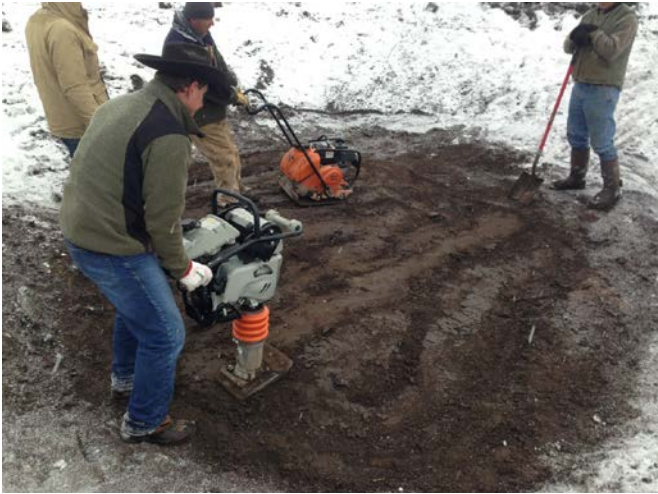
Photo 8: Compaction of clay layer at Lake Ann, CO

Each layer was placed in 3-inch lifts and compacted using a vibrating plate compactor. The clay layers were also compacted with a jumping jack.

The repair was completed on November 28, 2014. No issues have been reported since completion.
