# Western Dam Engineering Technical Note

A SEMI-ANNUAL PUBLICATION FOR WESTERN DAM ENGINEERS

## Inspecting Corrugated Metal Pipes in Embankment Dams

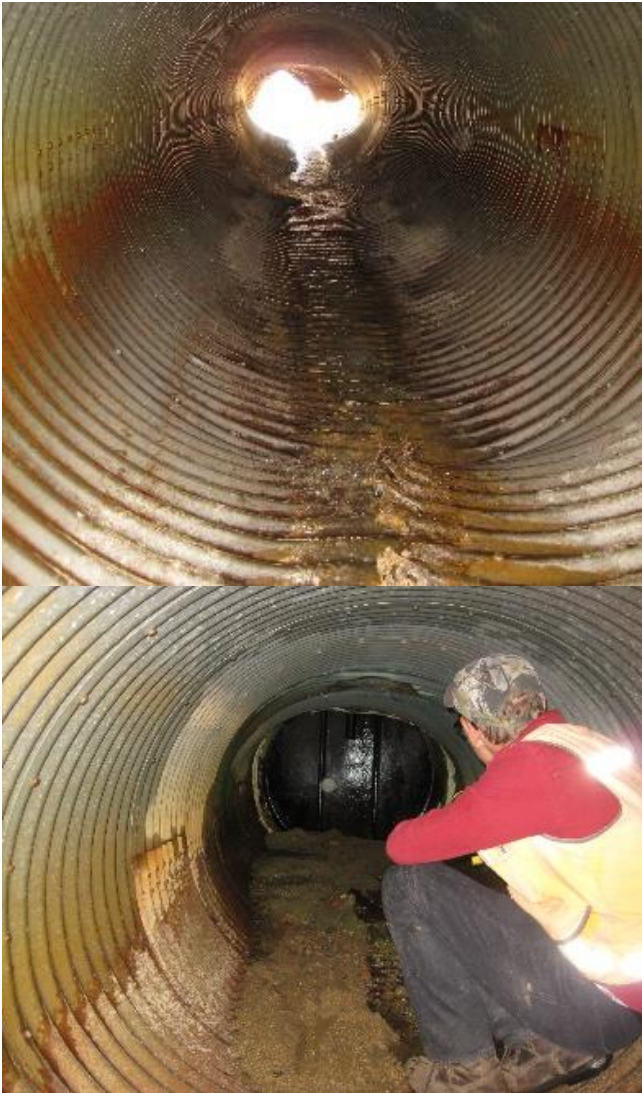
The pipe invert is particularly susceptible to corrosion since it is exposed to the flow of water for the longest length of time. CMPs that have inverts with sags could trap water and further increase the potential for and rate of corrosion. Other likely susceptible locations include pipe connections and areas of pipe deformation. Once the corrosion process extends through the wall thickness, a hole or void develops within the conduit, which can allow embankment soils to erode into the conduit. If not detected early, this defect can lead to an internal erosion failure and potentially a breach of the embankment. **Figure** shows

a 48-inch CMP internal erosion failure in progress as the result of corrosion.

Figure 4. 48-inch CMP Failure Due to Corrosion

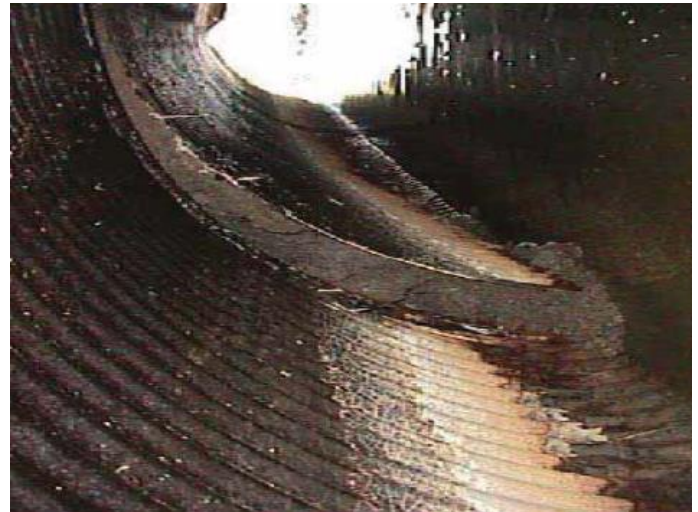
Construction defects can include joint settlements or slippage and conduit deformations. CMP is flexible and is designed to deform. The surrounding soil provides stiffness and load carrying capacity for the conduit. If the surrounding backfill soil is not adequately compacted or if large equipment is used over the pipe during construction without adequate backfill, deformations are likely to occur. Further, if the foundation is subject to large differential settlements (and therefore spreading), joint slippage may occur. Joint settlements (as shown on Figure 5) provide an

immediate path for embankment soils to erode into the conduit. Deformations (as shown on Figure 6) can weaken the pipe and/or introduce strain causing the pipes protective coating to weaken leading to accelerated deterioration.

Figure 5. Joint Settlement in a CMP Conduit [2].

- Construction defects, where the CMP conduit has settled or deformed (as shown previously on Figures 5 and 6)
- Major corrosion, where the CMP conduit is no longer structurally sound (as shown on Figure 9)

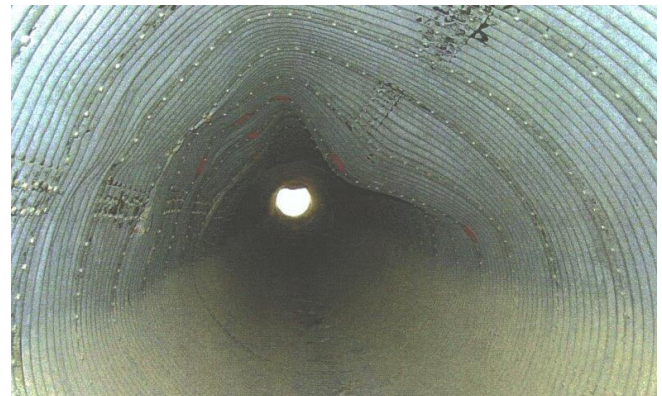
Figure 6. Deformation in a CMP Conduit [1].

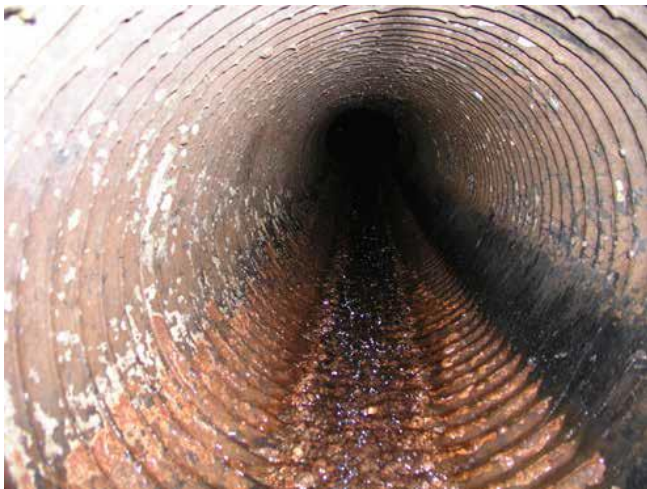
- Minor corrosion, where water is not yet flowing through the walls of the CMP conduit (as shown on Figure 7) – Dam owners should consider inspecting minor corrosion on a more frequent basis to ensure that the deterioration does not worsen to a point where failure is imminent.
- Minor abrasion, where flow through the conduit has removed or damaged the protective coating of the CMP conduit – Similarly, dam owners should consider inspecting minor abrasion defects more frequently to ensure the abrasion does not worsen.

Figure 7: Minor Corrosion in a CMP Conduit [5].

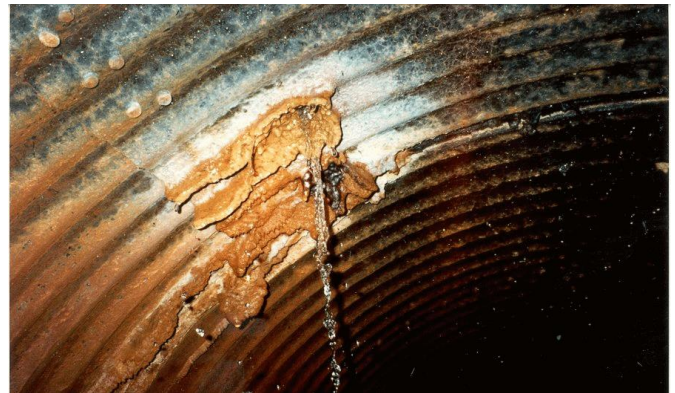
- Moderate corrosion, where water is flowing through the walls of the CMP conduit (as shown on Figure 8), but little to no embankment material has eroded into the

Figure 8. Moderate Corrosion in a CMP Conduit [1].

conduit. Some additional remedial efforts (such as low pressure grouting using traditional cement-based grouts or chemical grouts) should be undertaken if a minor amount of embankment material has eroded into the conduit resulting in suspected void(s) along the outside of the conduit.

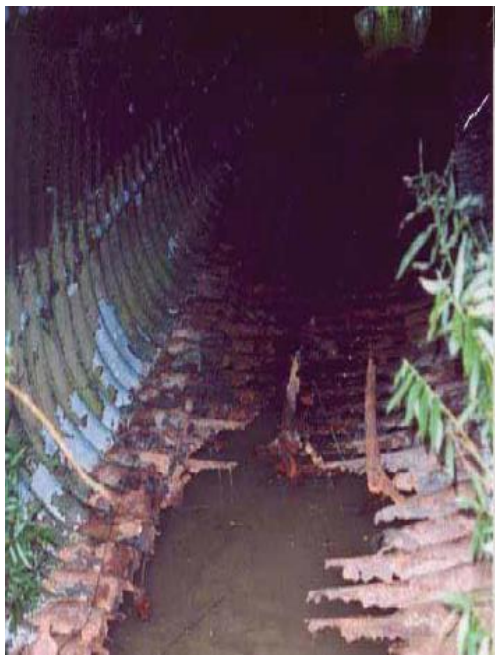
Figure 9. Major Corrosion in a CMP Conduit [2].

Replacement methods will typically involve an open-cut to ensure that the deficient CMP conduit is removed and a new properly designed and constructed conduit is installed. Replacing the CMP conduit has the potential added benefit of allowing placement of a filter diaphragm or completing improvements that may extend the service life of the dam embankment.
