Western Dam Engineering

Technical Note

You Con-du-it; How to Fix a Leaky Pipe

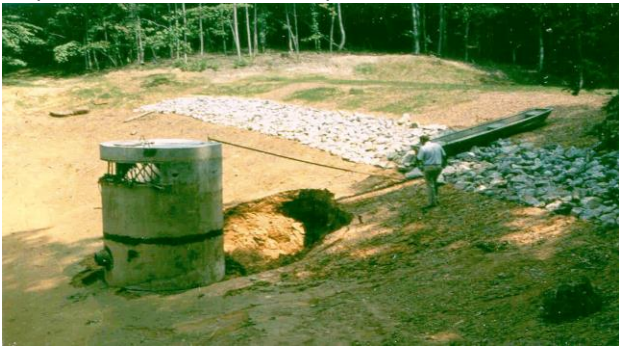
Photo 1: Sinkhole around a spillway riser²

Exterior inspection of the areas above and surrounding the conduit can provide clues about the condition of the conduit. Depressions, sinkholes, or cavities noted along the outlet conduit alignment on the surface of the embankment are indications that internal erosion or backward erosion piping is likely occurring. Seepage areas may also be indicated by changes in vegetative color or excessive vegetative growth on the embankment dam surface. Cloudy discharge or sediment deposits at toe drains or conduit outlets are other external indicators of potential internal erosion issues of the embankment along or into the conduit. Unexplained outlet discharge unrelated to outlet operation or known leakage past the outlet gate is also an indication of potentially deteriorating conditions. If any of these indicators is observed during an exterior inspection, photographs should be taken and the areas monitored for continued changes. These exterior indicators warrant an inspection of the conduit's interior if one has not been recently completed.

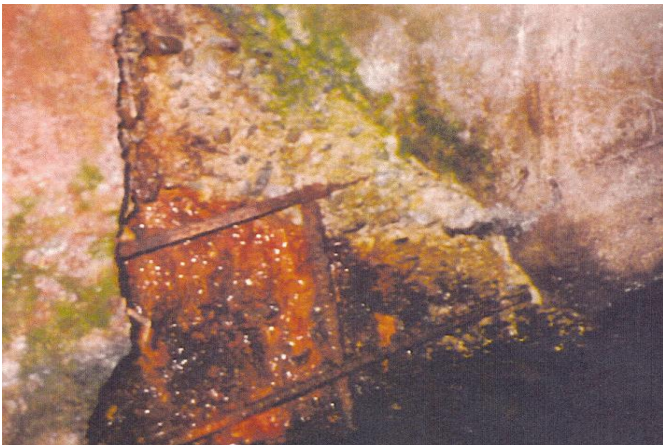
Photo 4: Spalled concrete inside a conduit.²

Methods to repair spalled concrete within concrete conduits are similar to that of typical concrete structures. The surface must first be prepared by removing the deteriorated concrete down to sound material. Reinforcing steel exposed for more than one-third of its circumference should be completely exposed to provide clearance around the reinforcement for the repair material.

The final prepared surface should be free of all loose aggregate, spalled concrete, and dirt, leaving the aggregate of the remaining concrete partially exposed

to achieve a good bond between the existing and new material. For most small to intermediate sized conduits, the conduit thickness isn't sufficient to develop reinforcement, so dowels typically are not used. All surfaces to be covered with fresh concrete should be moistened to saturated surface dry condition and all standing water removed, leaving the surface damp immediately prior to receiving concrete. A high strength, 3/8-inch concrete mix is usually prescribed for the repairs (pre-mixed Sika product or similar).

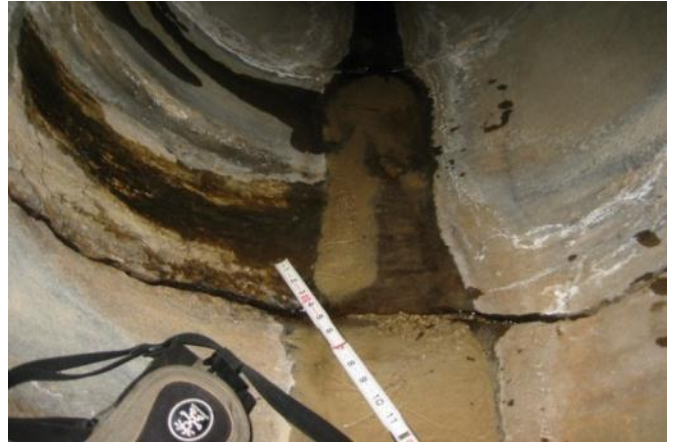
Since RCPP conduits are typically made up of short sections of pipe connected by gasketed bell and spigot type connections, the joint locations are a common place for deterioration or poor construction practices to manifest. First, the cracks or joint offsets should be thoroughly cleaned of any embankment material and cleared of all loose or spalled concrete. For larger cracks, offsets, or failed joints, grout injection helps to fill any voids that may have developed behind the conduit due to localized erosion at the crack or joint locations.

Photo 5: Crack in precast concrete conduit.

For this method of repair, the opening should be temporarily sealed, creating a bulkhead, so that grout can be injected behind the conduit. Non-shrink grout can be applied from the interior of the conduit to develop the bulkhead and grout injection ports can be installed through the grout, around the circumference of the crack, at a spacing that will allow the grout to fill any voids that may have developed. Generally, grout injection behind the conduit should be completed so that the injection pressures do not exceed about half the lateral earth pressure of the embankment at the location of the crack.

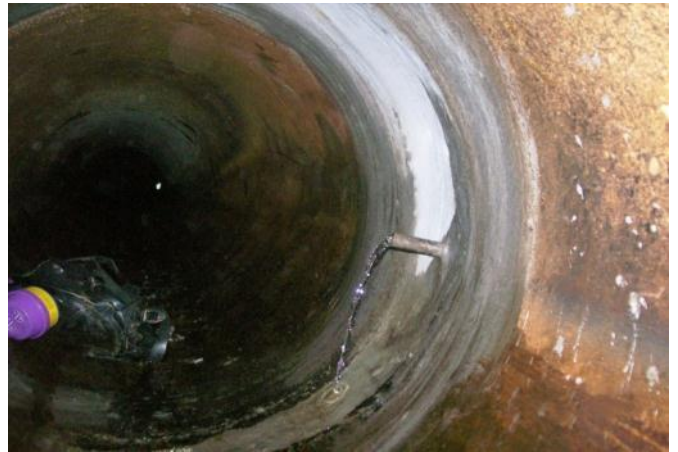
Photo 6: Grouted joint offset with grout port installed for injection grouting behind conduit.

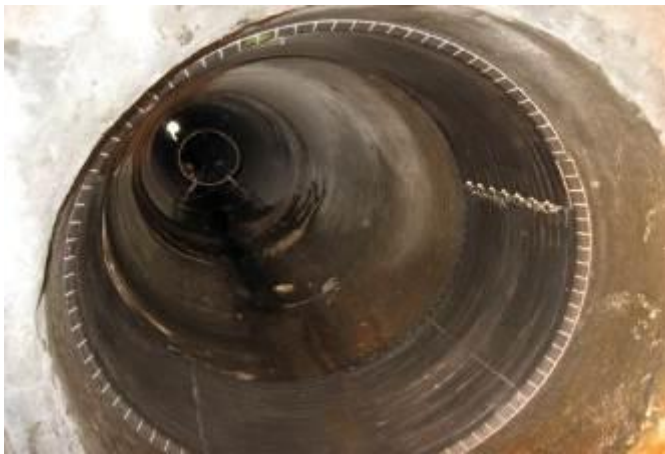
Photo 7: Link-Pipe Grouting Sleeve after installation over cracked conduit.

For large cracks, redundancy may be desired and a mechanical repair can be implemented by installing a seal around the inside of the conduit after injection grouting has been completed. A mechanical seal should span the original crack to overlap sound concrete (typically 6-9 inches on either side of the crack). Various products are available to create this seal (Link-Pipe Grouting Sleeve™, EPDM rubber seal,

etc.). Many common mechanical repairs consist of a rubber seal with a stainless steel band that helps to compress the rubber seal against the conduit by expanding the band once in place. It is important that any mechanical repairs implemented within the conduit be tapered at the ends to minimize flow obstruction. Because seepage can sometimes extend away from the conduit, it is important that repairs like these are monitored by regular exterior and interior inspections to ensure no new signs of internal erosion, backwards piping, or seepage into or along the conduit develop.

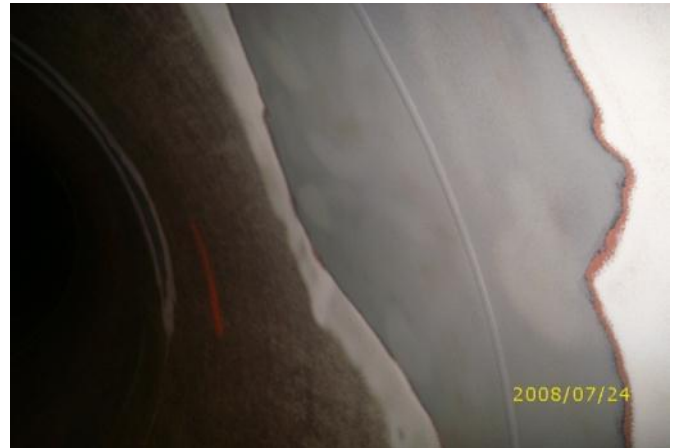
Photo 8: Sandblasted steel surface in preparation for applying new epoxy coating at joints.

A common maintenance issue for steel liner encased conduits is deterioration of the coating system and corrosion of the conduit. Because the joints are painted in the field, the coating at joint locations often deteriorates faster than other portions of the pipe. For that reason, proper care and quality control is critical during construction. Remediation of the liner coating system typically includes sandblasting the interior of the liner to expose the bare steel and applying two coats of high solids epoxy paint (typically ~7 mils per coat).

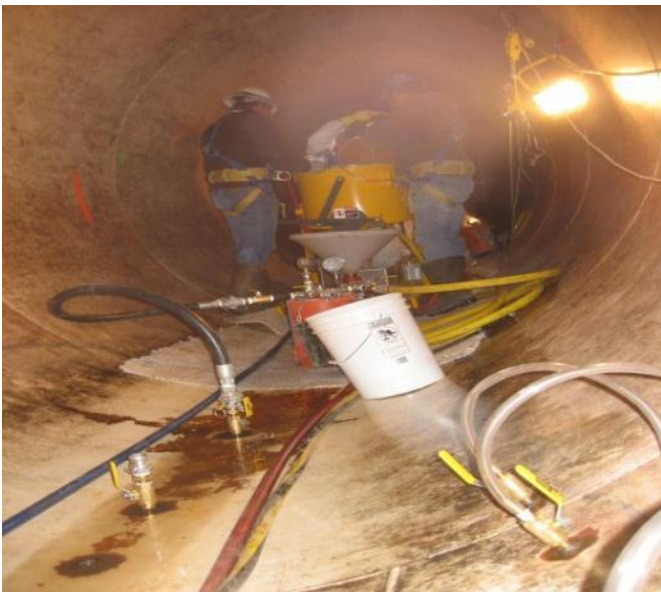
Another common issue in steel liner encased conduits is voids within the concrete encasement due to poor consolidation of the concrete. This issue is most prevalent in encasements that are constructed monolithically (no horizontal construction joints). In these cases, consolidation beneath the steel liner can be difficult during construction. Voids behind the steel liner are usually detected during a conduit inspection from visual confirmation of seepage at the downstream end of the encasement or the sound of water moving behind the conduit.

Photo 9: Injection grouting voided encasement behind steel liner.

Sinkholes, depressions, or cavities on the surface of the embankment, along the conduit alignment, can indicate piping and the potential for voids within the encasement. Because of the presence of the welded steel liner, seepage into the conduit is typically not an issue. Repairs to voided encasements are generally made by injecting grout behind the steel liner. Pressure grouting behind the steel liner is done via

primary injection ports that are drilled and installed along the invert, spring line, and crown of the voided encasement to ensure that the grout can travel and vent as necessary. Secondary grout ports can be added at intermediate locations if communication between the primary grout ports is not confirmed (air or grout return). Grout pressures should be monitored during injection and each port grouted until project criteria for grout refusal is met or grout return is achieved at the next grout port location.

Communication between the voids in the encasement and the surrounding embankment could exist; therefore, pressures should be limited to prevent fracturing the embankment behind the encasement.

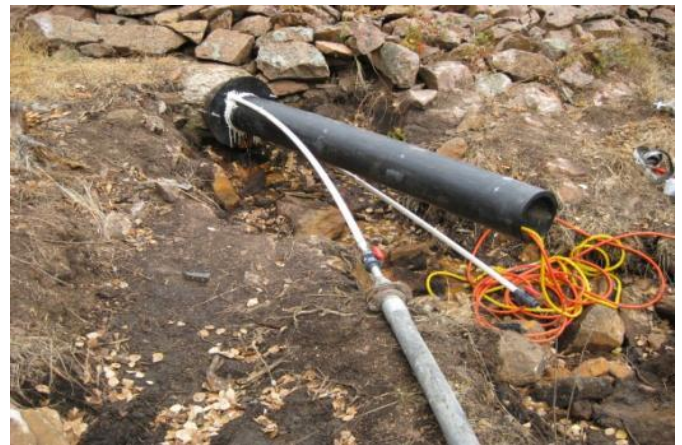
Photo 10: Grouting HDPE liner pipe.³

Historically, when compared with steel or concrete, plastic pipe has not been commonly used as the primary material in outlet conduits. FEMA (2007) describes the uses of plastic pipe in embankment dams. Plastic pipe is more typically used in small-diameter toe drain systems. Plastic pipe, however, has been used in lining rehabilitation of existing conduits. Plastic conduits are generally considered to have a shorter service life than RCPP conduits (approximately 50 to 100 years). However, in environments where the water or soil may cause premature degradation of concrete and steel, plastic conduits may be a favorable alternative. Lining rehabilitation with plastic pipe is typically accomplished by one of two methods, slip lining (typically using HDPE) or cured-in-place pipe (CIPP) liners. Slip lining is completed by installing a smaller, "carrier pipe" into a larger "host pipe," grouting the annular space between the two pipes, and sealing the ends. Preventing collapse of the interior carrier pipe during grouting of the annulus is critical to the success of a lining rehabilitation project. Pressures should be monitored during grouting and, in some cases, the carrier pipe filled with water to provide additional resistance to collapse.
