Low-Level Conduits – Rehab or Replace?

Introduction

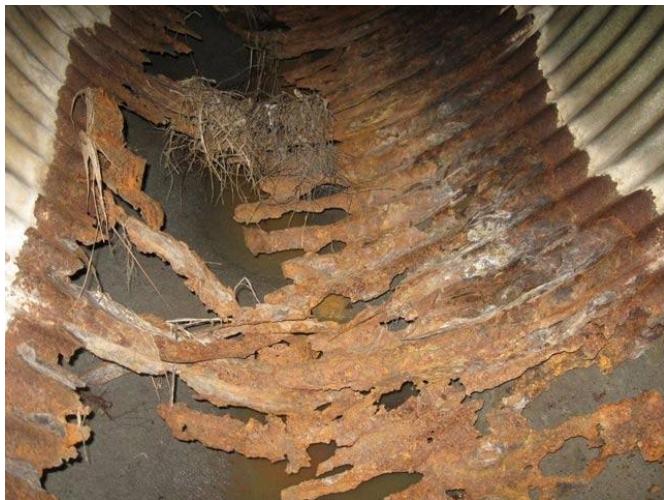
Photo 1: Severely deteriorated CMP.¹

- Not applicable for severely deteriorated conduits (i.e., conduits with severely compromised structural integrity, open joints or holes, pipe deformities, or conduits believed to have voids along the outside of the pipe). See Photo 1.
- Limitations for conduits with slight bends, deformities or non-uniform diameters.
- Most likely will require specialized contractors, and equipment for installation.
- May adversely affect seepage paths around the exterior of the existing conduit.

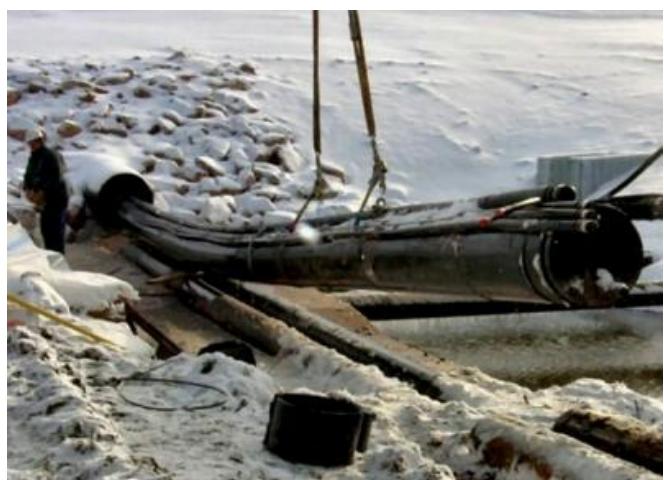
Photo 2: Installing HDPE Liner pipe.²

Of the two rehabilitation alternatives noted above, the more common option is sliplining (see Photo 2). High density polyethylene (HDPE) and properly coated steel pipe are the two most common pipes selected for sliplining rehabilitation and have similar design parameters. With little maintenance the service life of HDPE pipe can typically range between 50 and 100 years. Steel pipe requires provisions for adequate coating to provide similar levels of design life. Fiberglass reinforced pipe (FRP) and polyvinyl chloride (PVC) have also been used, but have drawbacks with regards to jointing (i.e., bell and spigot) and brittleness. Design considerations along with a comparison of HDPE pipe and coated steel pipe are summarized below.

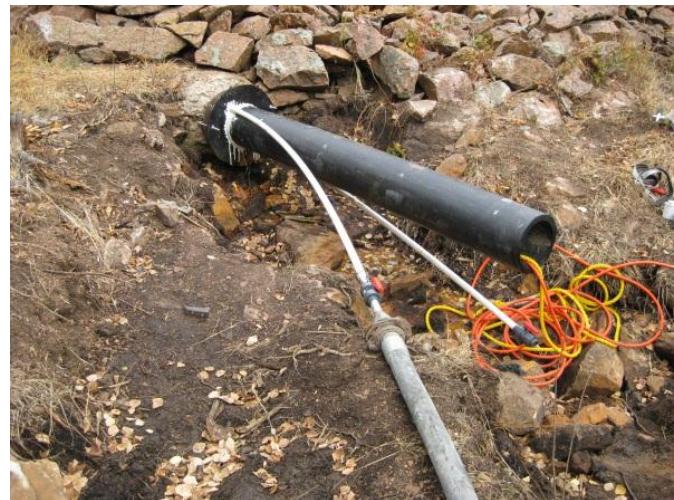
Photo 3: Grouting HDPE Liner pipe.³

Grouting: Grouting the annular space between the new pipe and the existing pipe is essential (see Photo 3). Only contractor's experienced in this type of grouting should be used for this specialized work. Typically grouting is completed from the downstream end with grout pumped to the upstream end through tremie pipes. Multiple tremie pipes of increasing lengths are used to inject grout and reduce the travel distance of the grout. Grouting should continue until the entire annular space has been filled and no voids remain. Vent/observation pipes are used to verify grout has filled the annular space. Securing bulkheads to contain the grout is also critical.
