**Design Standards No. 13**

## **Embankment Dams**

**Chapter 3: Foundation Surface Treatment  
Phase 4 (Final)**

**DS-13(3)-2: Phase 4 (Final)**  
**July 2012**

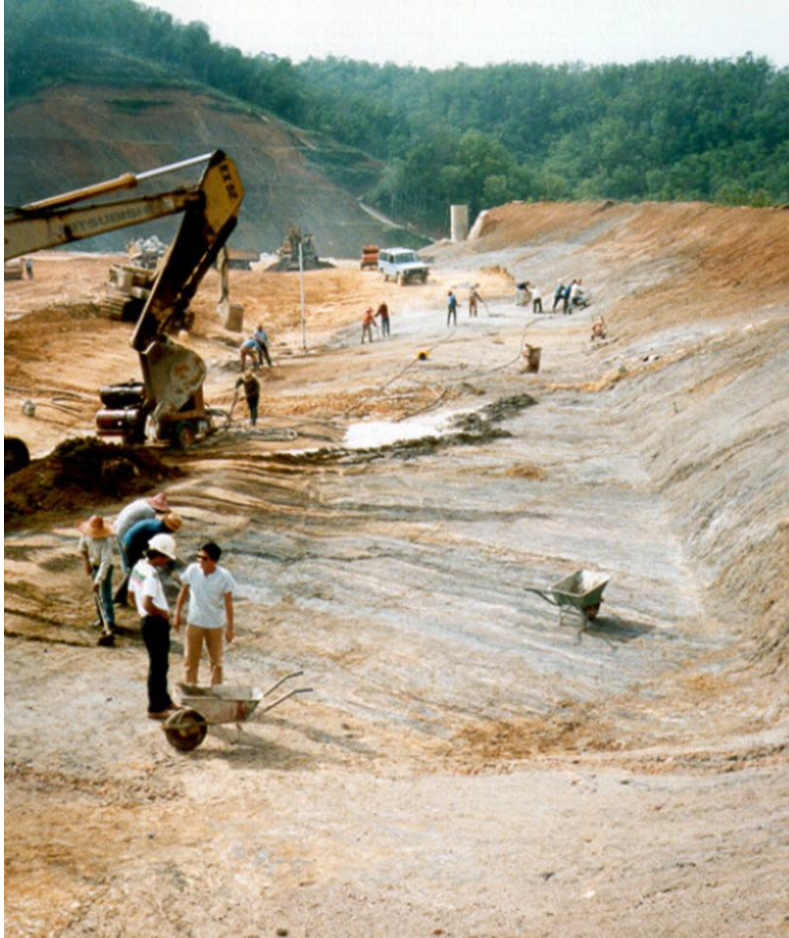
Figure 3.2.1-1 All organic or other unsuitable materials should be removed from soil foundations.

The minimum treatment of any foundation consists of stripping or removing organic material such as roots and stumps, sod, topsoil, wood, trash, and other unsuitable materials. When the foundation is soil, all organic or other unsuitable materials, such as stumps, brush, sod, and large roots should be stripped as shown in figure 3.2.1-1. Materials such as sod and topsoil can be reused to cover areas that are to be seeded, while other materials should be wasted. When the foundation is rock, the foundation should be treated as shown in figures 3.2.1-2 through 3.2.1-5. These figures detail slope modification and foundation excavation.

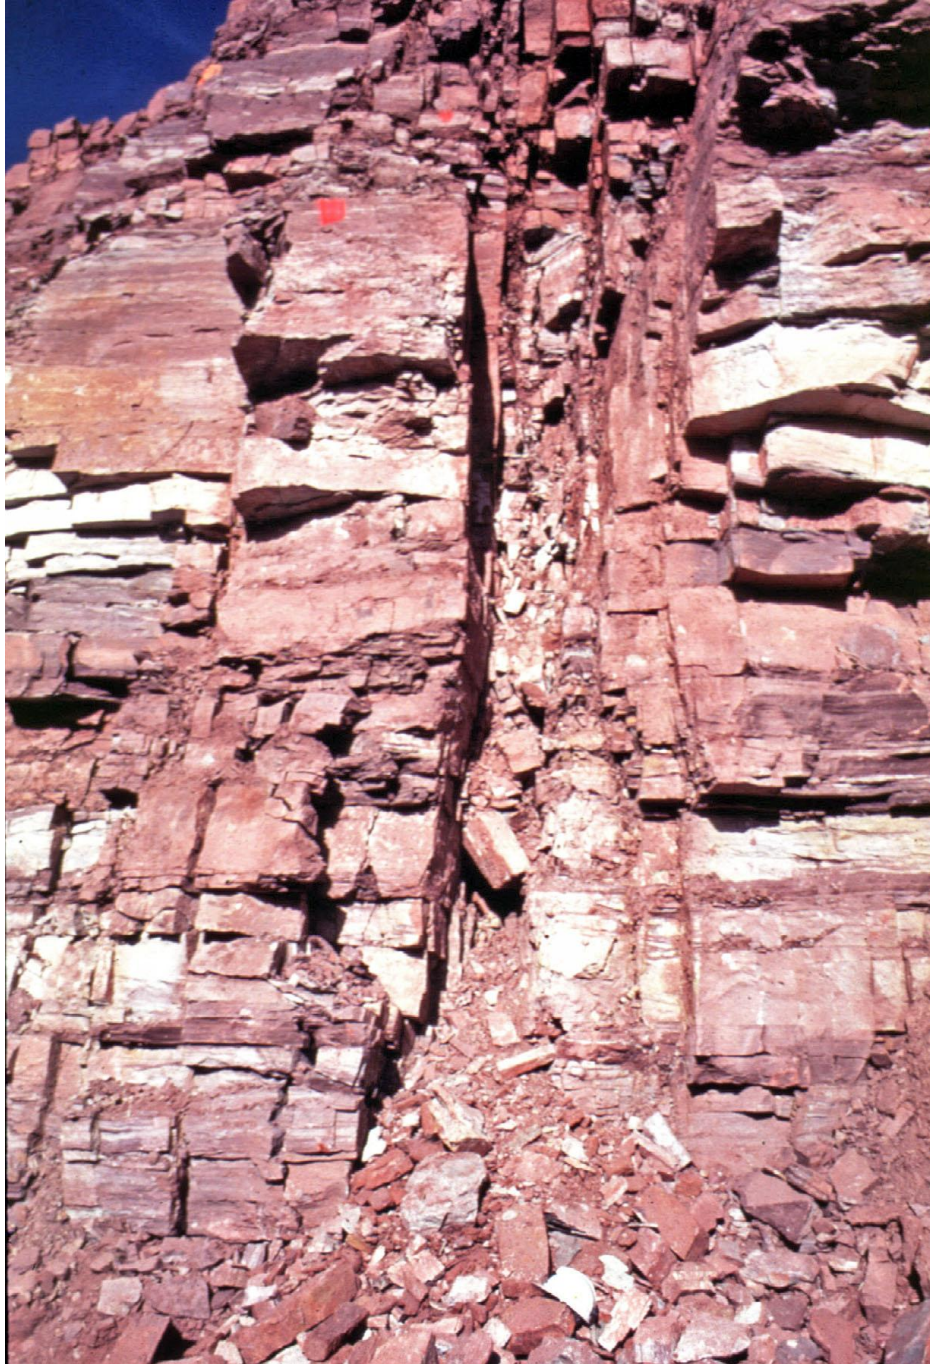
**Figure 3.2.4.2-1 Upper Stillwater Dam. Features such as this shear zone create foundation irregularities that require treatment. The surface should be cleaned of all loose and weathered rock, and the shear zone should be filled with dental concrete. Alternatively, the surface might be reformed by smooth blasting techniques.**

When overburden is stripped to bedrock, carefully clean the rock surface and all pockets or depressions of soil and rock fragments before the embankment is placed as shown in figures 3.2.4.2-1, 3.2.4.2-2, 3.2.4.2-4, 3.2.4.2-5, and 3.2.4.2-6. This may require compressed air or water cleaning and handwork as shown in figure 3.2.4.2-7. Rock surfaces that slake or disintegrate rapidly on exposure must be protected immediately with embankment material, concrete (dental, shotcrete), or by other means such as delaying final excavation until immediately before fill placement. Foundation rock should be shaped to remove overhangs and steep surfaces (figure 3.2.4.2-8). High rock surfaces must be stable during construction and should be cut back to maintain a smooth, continuous profile to minimize differential settlement and stress concentrations within the embankment. Final slopes should be 0.5H:1V or flatter. Beneath the impervious zone, all overhangs should be removed; stepped surfaces steeper than 0.5H:1V and higher than 0.5 foot should be excavated or treated with dental concrete to a slope of 0.5H:1V or flatter (figure 3.2.4.2-9). Outside the impervious zone, all overhangs should be removed, and stepped surfaces steeper than 0.5H:1V and higher than 5 feet should be excavated or treated with dental concrete to a slope of 0.5H:1V or flatter. These are guidelines. The final decision on shaping rock surfaces should be made during the foundation inspection and approval process.

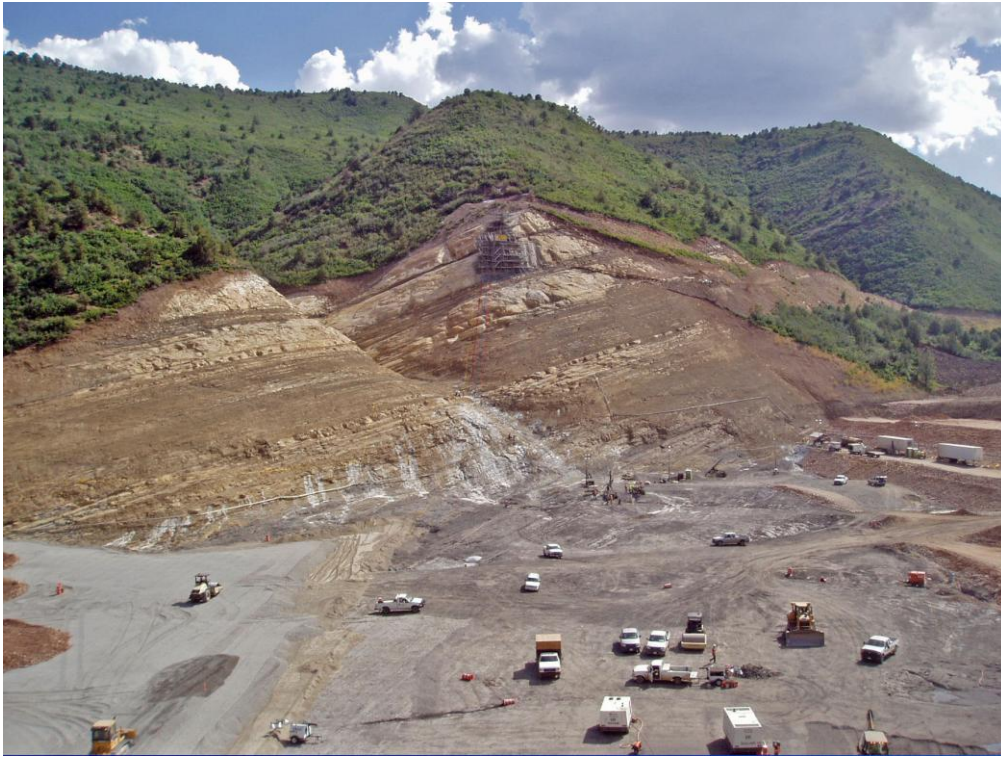
**Figure 3.2.4.2-2 Ridges Basin Dam. This dam foundation was shaped to ensure proper compaction of fill and to prevent stress irregularities in the overlying embankment.**

placed without differential settlement (see figure 3.2.4.2-2). If the irregularities are small enough and discontinuous both horizontally and vertically, overexcavation can be appropriate. Generally, the foundation surface can be shaped adequately by conventional excavation or smooth blasting. When smoothing of irregularities would require excessively large quantities of excavation or blasting that could damage the foundation, shaping with dental concrete may be appropriate (see figure 3.2.4.2-3).

Shape the foundation to ensure proper compaction of fill and to prevent stress irregularities in the overlying embankment (see figures 3.2.4.2-2 and 3.2.4.2-8). The foundation surface should be shaped by excavating or by filling with concrete to obtain a smooth, continuous surface.

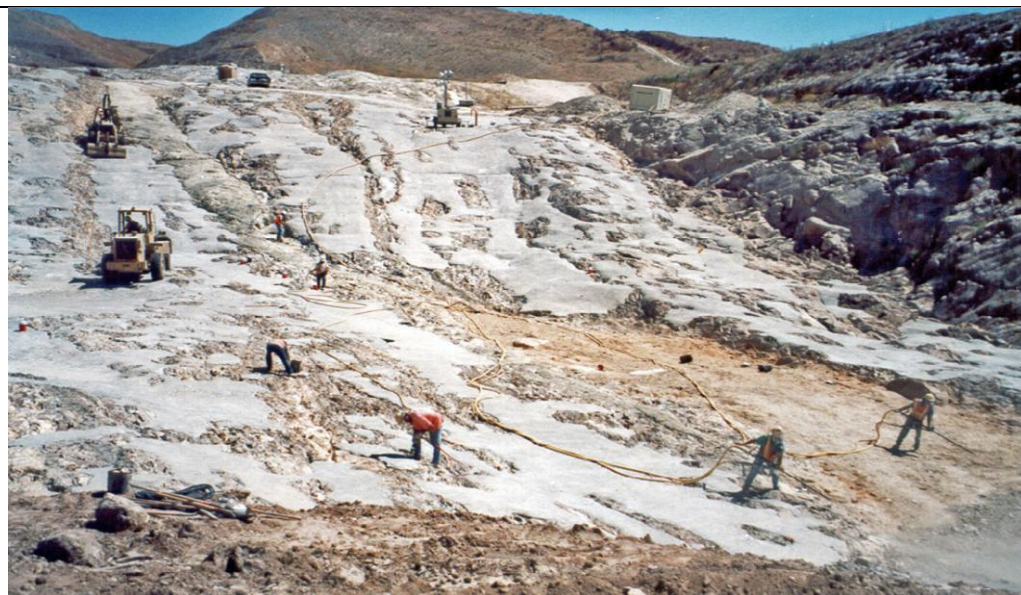
**Figure 3.2.4.2-3 Extensive use of dental concrete used to fill potholes, grooves, and channels in rock surface.**

Slush grout or joint mortar should be used to fill narrow cracks in the foundation as shown in figures 3.2.4.2-10 and 3.2.4.2-11. However, they should not be used to cover exposed areas of the foundation. Slush grout and joint mortar are composed of Portland cement and water generally for openings less than  $\frac{1}{2}$  inch or, in some cases, Portland cement, sand, and water generally for openings greater than  $\frac{1}{2}$  inch. The slush grout is preferably used just before fill placement to eliminate potential for hardened grout to crack under load as the fill is placed. Dental concrete should be used to fill potholes and grooves created by bedding planes and other irregularities such as previously cleaned shear zones and large joints or channels in rock surfaces as shown in figure 3.2.4.2-3. Formed dental concrete can be used to fillet steep slopes and fill overhangs.

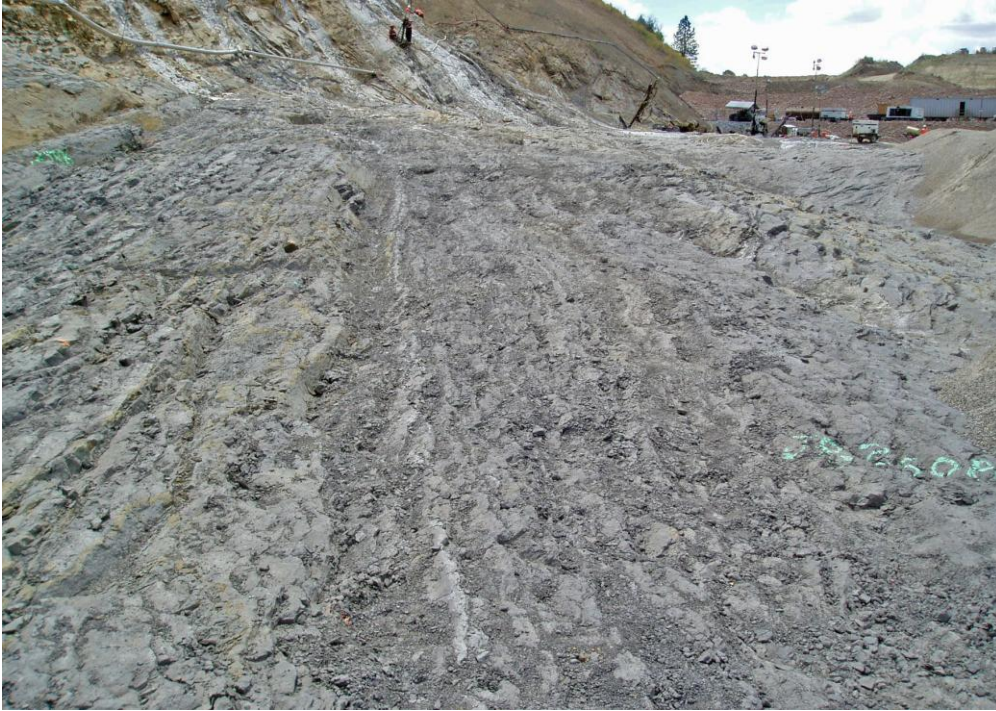
**Figure 3.2.4.2-6 Ridges Basin Dam. Foundation after stripping and before cleanup.**

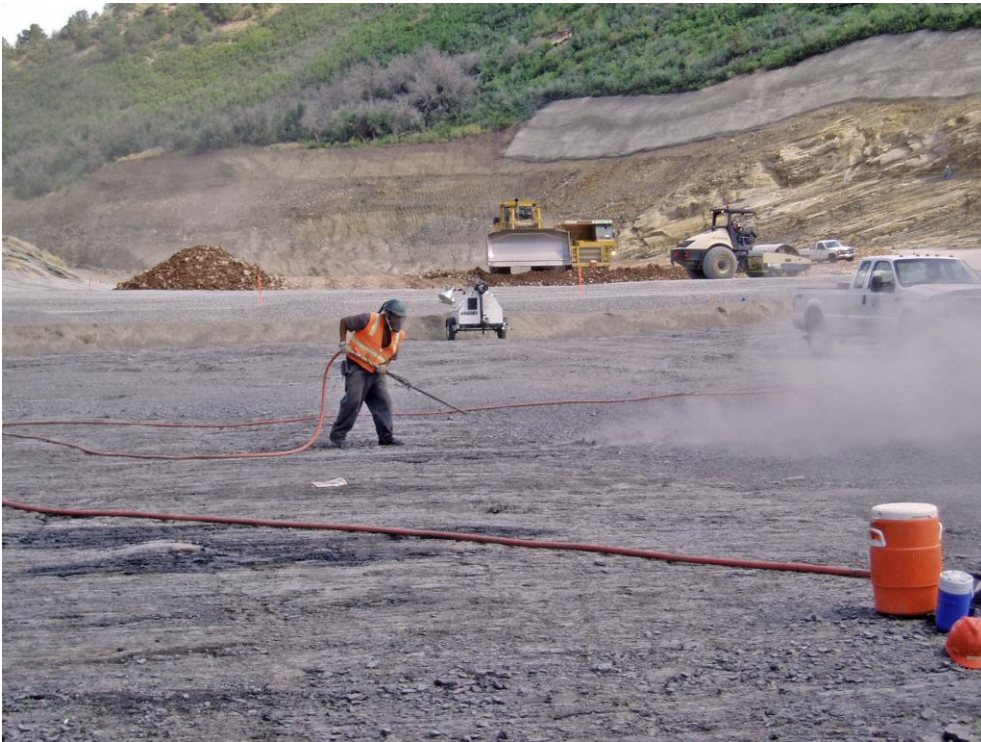
**Figure 3.2.4.2-7 Ridges Basin Dam. Foundation cleanup using compressed air blow pipe.**

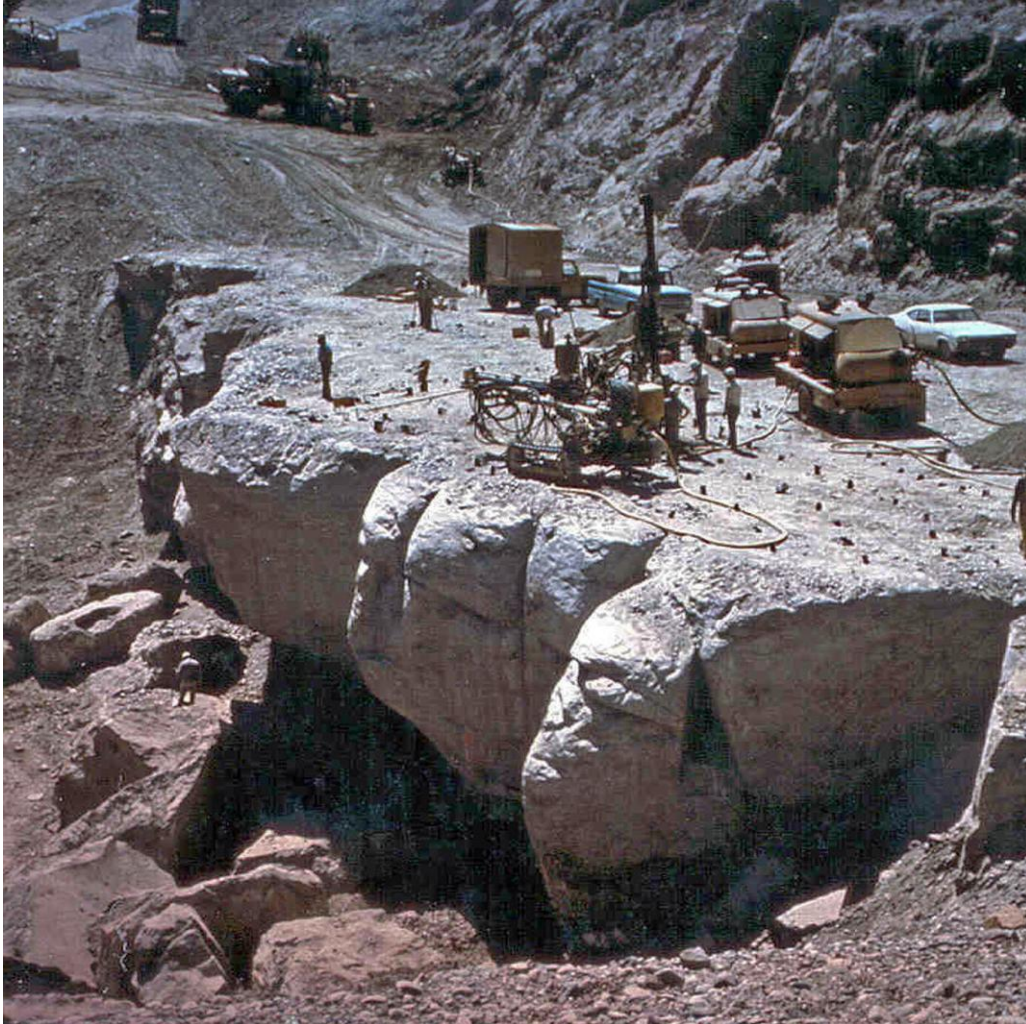
**Figure 3.2.4.2-8 Drilling blast holes to facilitate removal of a rock overhang at Teton Dam.**

Remove overhangs as shown in figure 3.2.4.2-8. Overhangs should be trimmed, or the undercut below the overhang should be filled with dental concrete. If concrete fill is used, grouting would be required to ensure a watertight joint between concrete and rock.

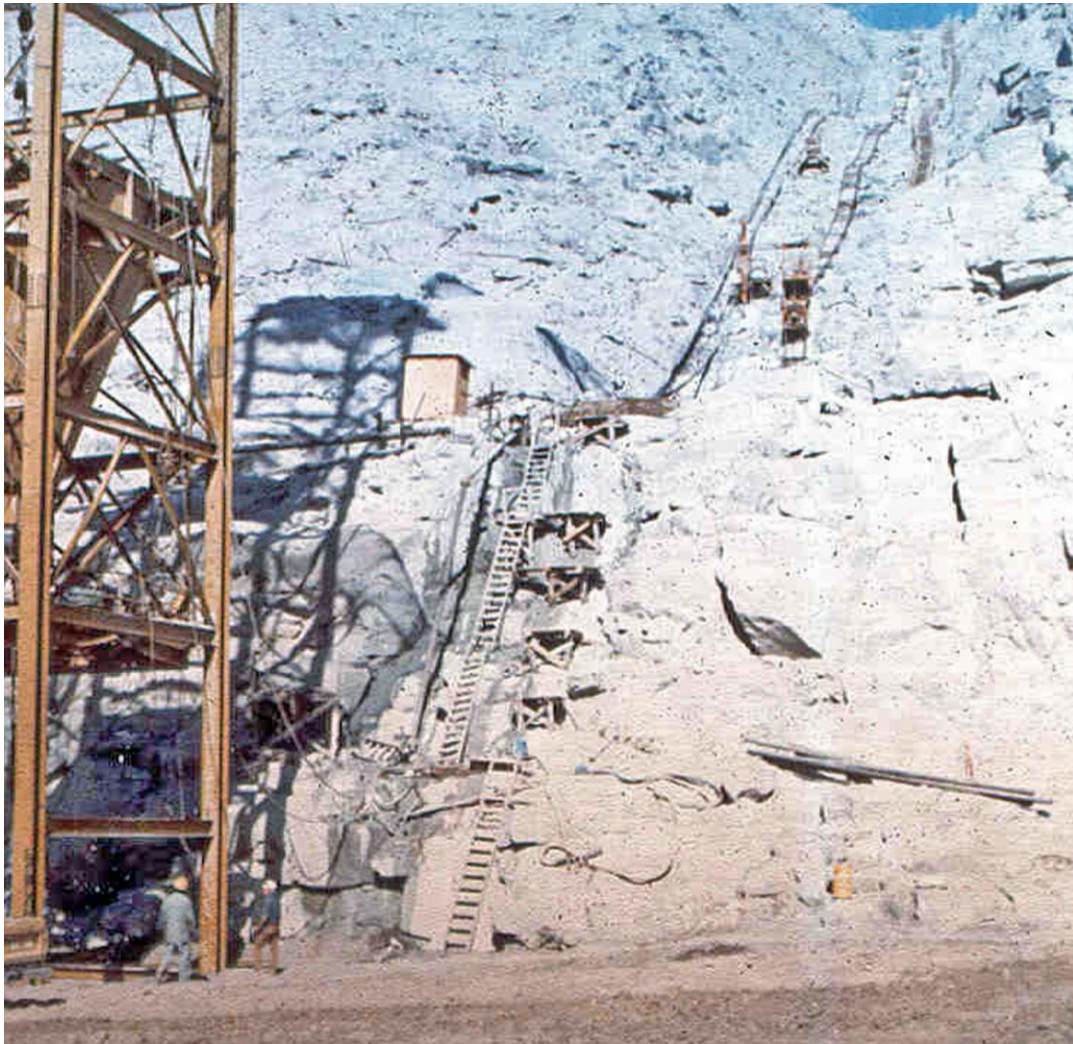
**Figure 3.2.4.2-9 Teton Dam. The stepped surface in this right abutment key trench could result in cracking and seepage problems in overlying embankment. Embankment may differentially settle adjacent to these surfaces, resulting in cracks.**

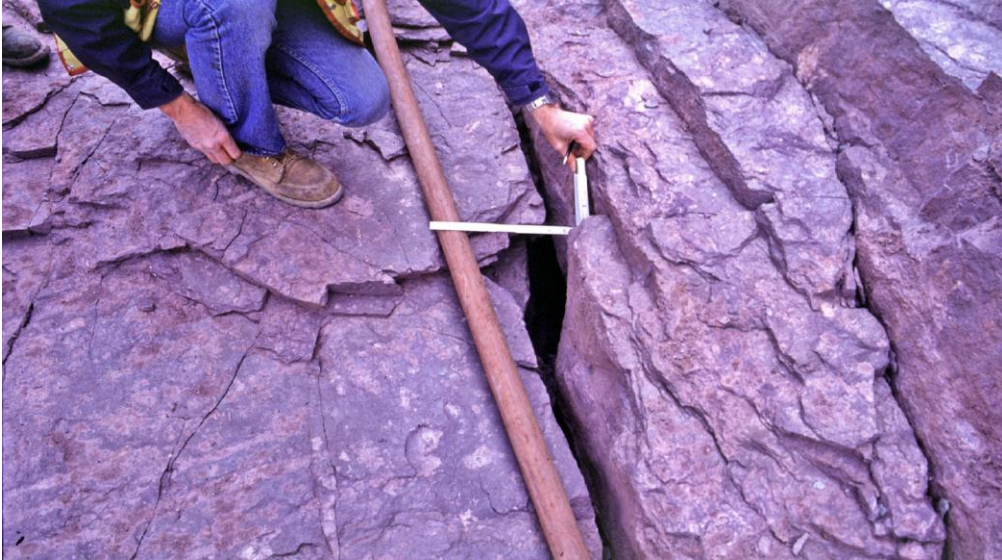
**Figure 3.2.4.2-10 Ridges Basin Dam. Open stress relief joint in foundation requires filling with slush grout.**

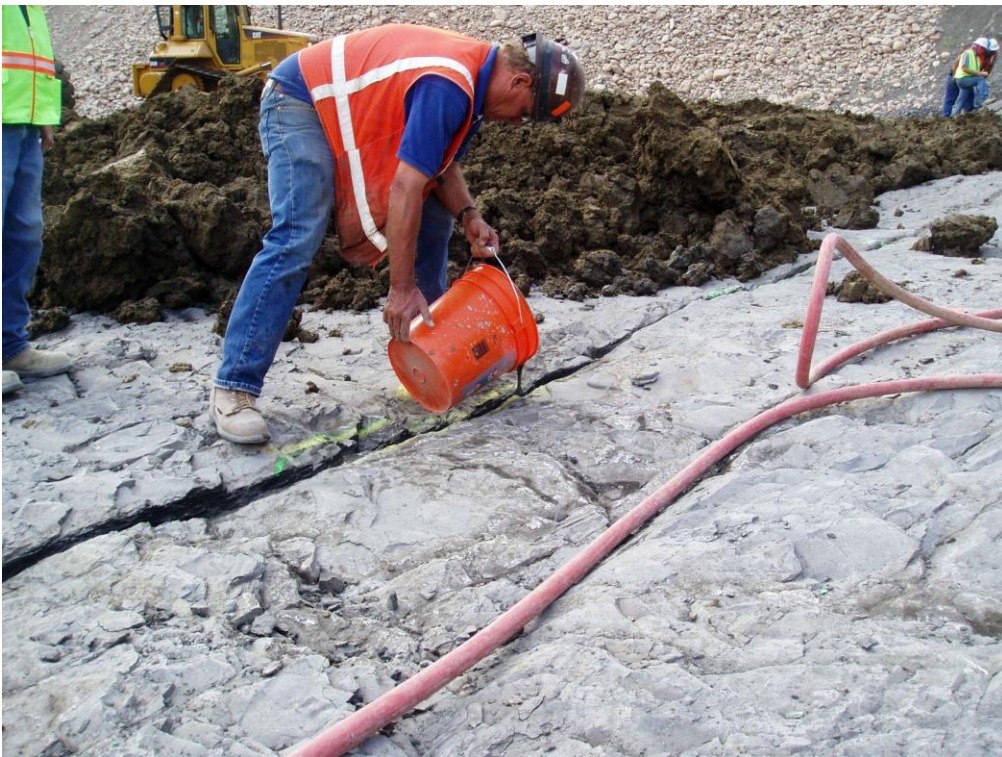
**Figure 3.2.4.2-11 Slush grout being applied to an open joint in a dam foundation.**

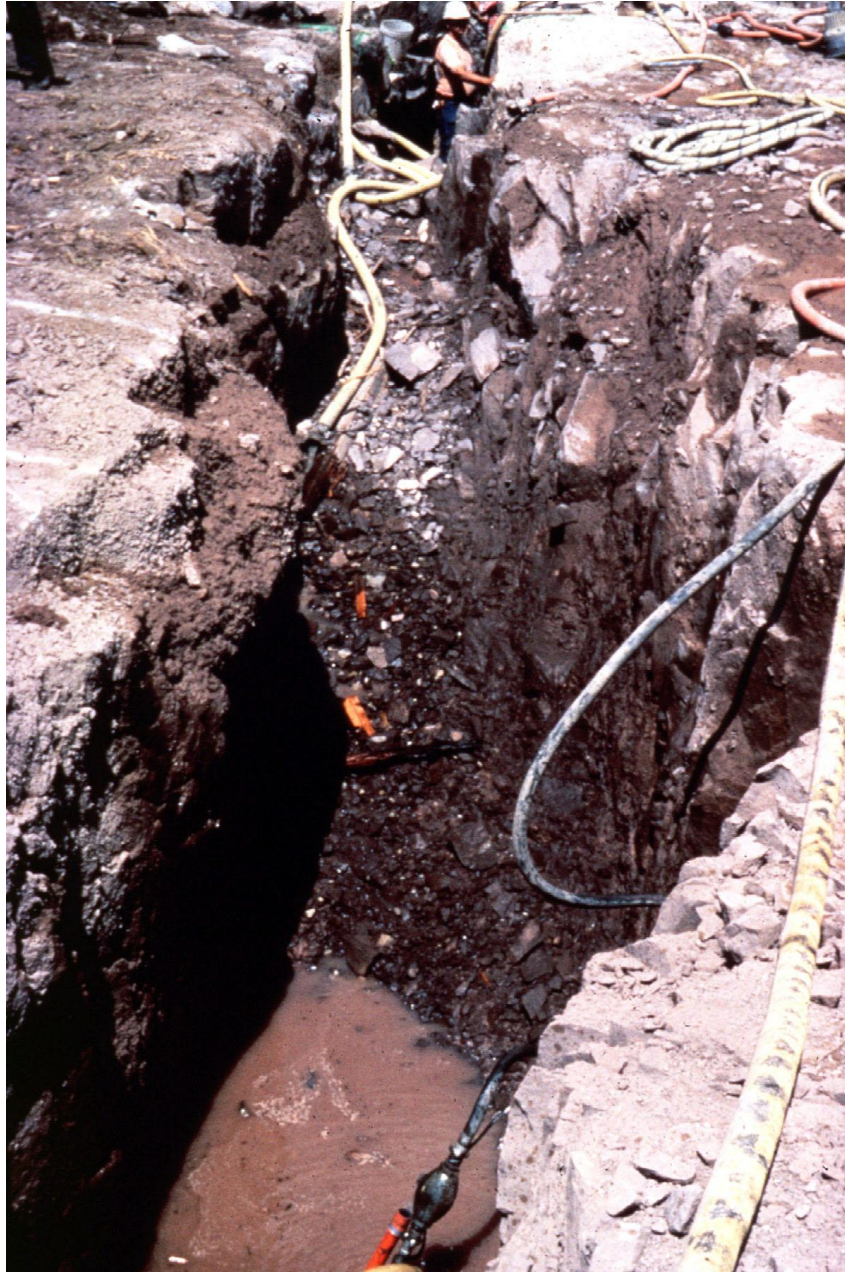
**Figure 3.2.4.2-12. Upper Stillwater Dam. Shear zone in foundation being cleaned out for concrete backfill.**

All loose or objectionable material should be removed by handwork, barring, picking, brooming, water jetting, or air jetting. Remove accumulated water from cleaning operations. When the rock surface softens or slakes by water washing, compressed-air jetting or jetting with a small amount of water added to the air should be used. Loose or unsuitable material in cavities, shear zones, cracks, or seams should be treated as follows (see figures 3.2.4.2-4 and 3.2.4.2-5 and figure 3.2.4.2-12):

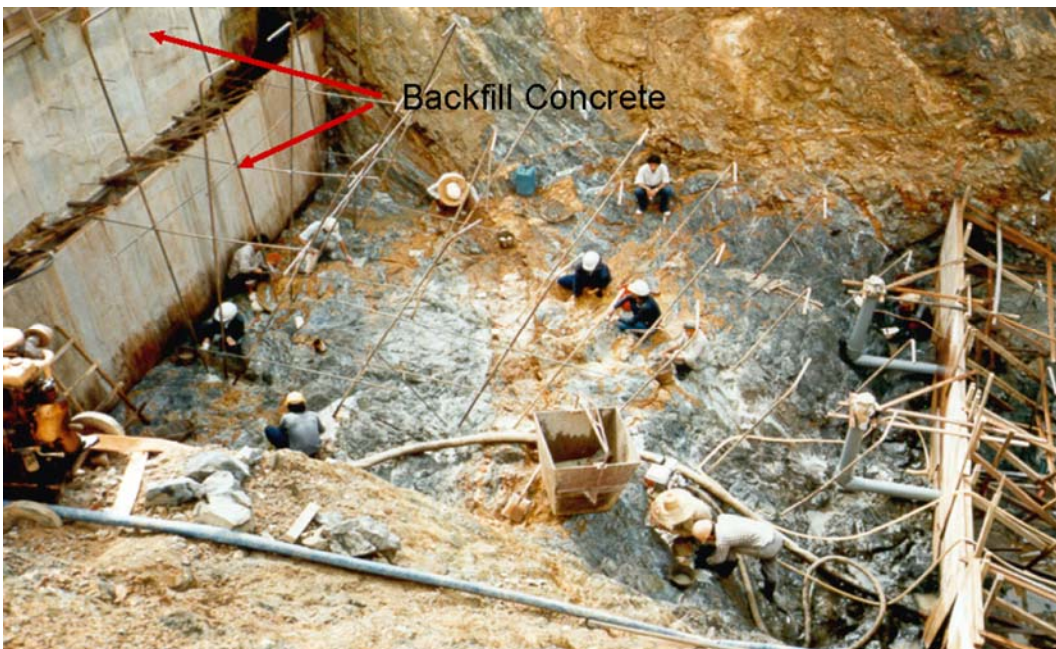
**Figure 3.2.6.1-1. Foundation cleanup is labor intensive and costly but should not be neglected.**

Foundation cleanup is labor intensive (as shown in figure 3.2.6.1-1) and costly yet necessary. When cleaning is neglected, it results in substandard foundations that do not meet design requirements. As appropriate, rock foundations should be cleaned by:

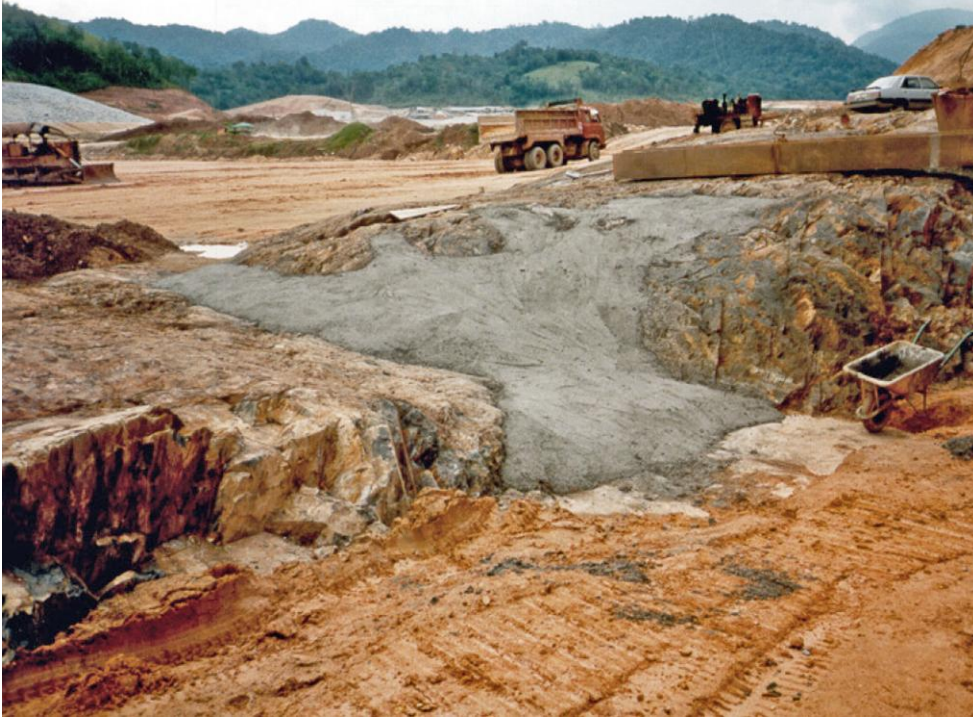
Figure 3.2.6.3-1 Dental concrete and acceptable vertical steps can be tolerated in the foundation.

Dental concrete is used to fill or shape holes, grooves, extensive areas of vertical surfaces, and sawteeth or stair steps created by bedding planes, joints, and other irregularities such as previously cleaned out solution features, shear zones, large joints, or buried channels (see figures 3.2.6.3-1 through 3.2.6.3-3). Formed dental concrete can be used to fillet steep slopes and fill overhangs. Placing a concrete mat over a zone of closely spaced irregularities may be appropriate in local areas. Dental concrete shaping can be used instead of removal by blasting when excessive amounts of excavation would otherwise be required.

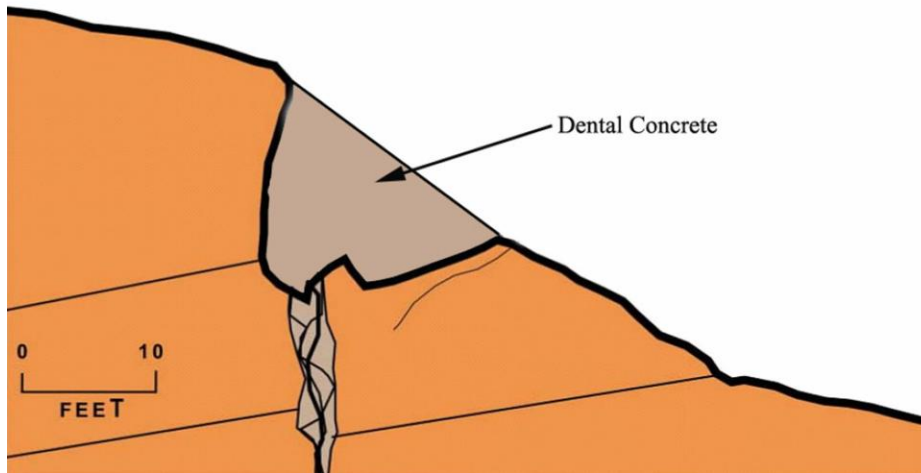
**Figure 3.2.6.3-3 Block is removed between fractured zone, bedding plane, and joints. Treatment to further shape the surface required dental concrete.**

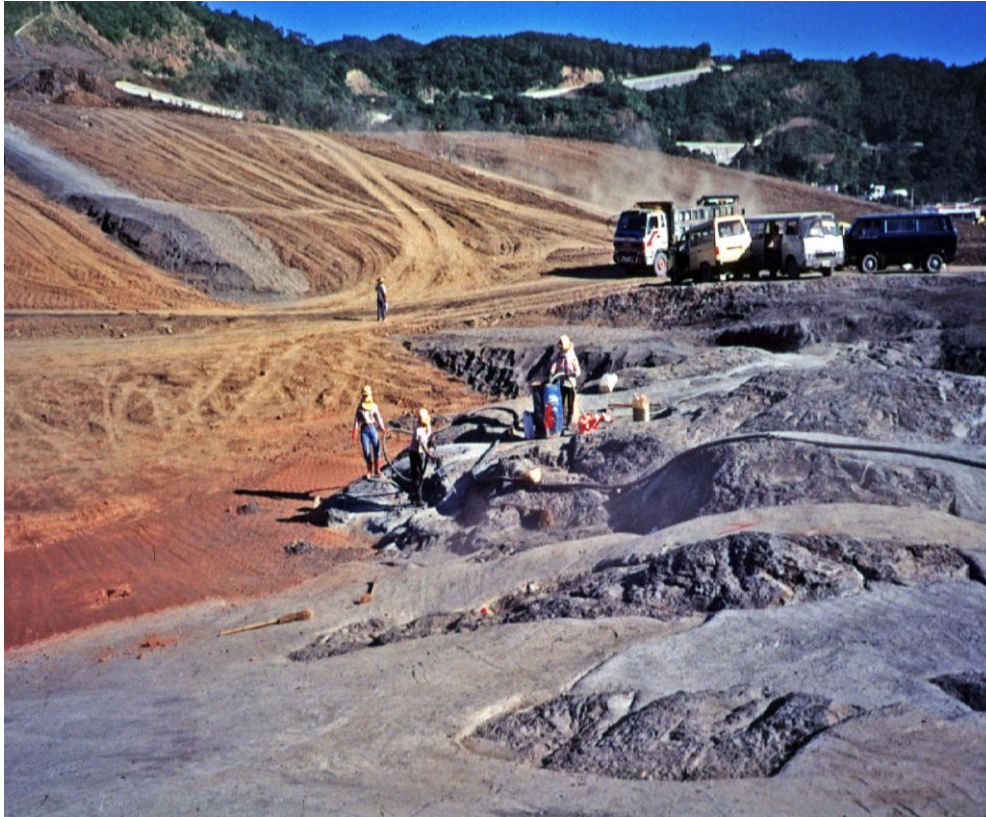
**Figure 3.2.6.3-4 Feathering at the ends of concrete placements should not be permitted. The edges of concrete should be sloped no flatter than 45 degrees.**

Slabs of dental concrete should have a minimum thickness of 2 to 6 inches depending on the quality of the foundation. Thin areas of dental concrete over rock projections on a jagged rock surface are likely places for concrete cracking and should be avoided by using a sufficient thickness of dental concrete or by avoiding the placement of continuous slabs of concrete over areas containing numerous irregularities on weak foundations. Feathering (thin edges) should not be permitted at the end of concrete slabs on weak foundations, and the edges of slabs should be sloped no flatter than 45 degrees as shown in figure 3.2.6.3-4.

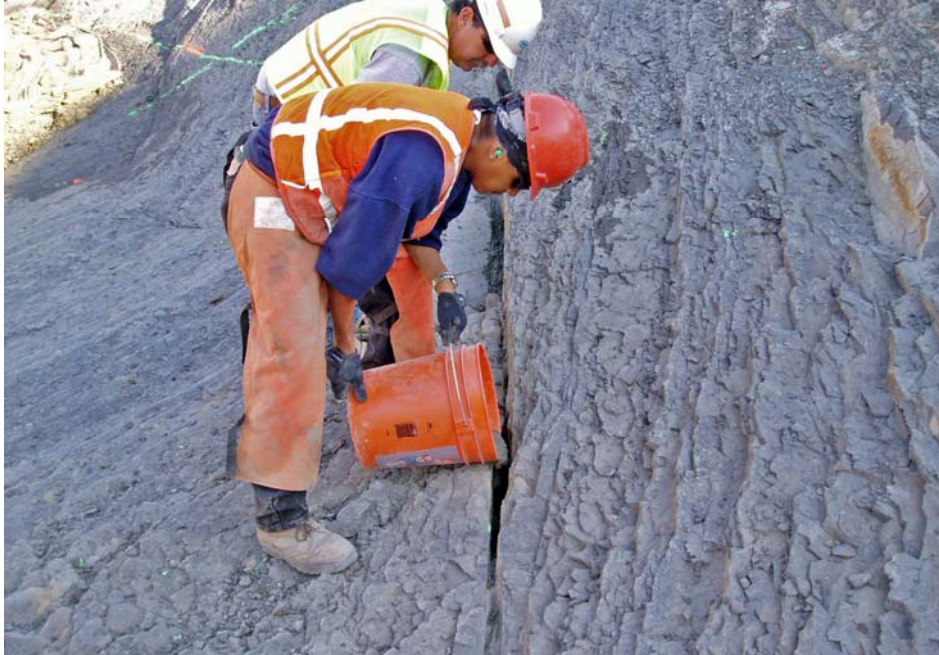
**Figure 3.2.6.4-1 Ridges Basin Dam. Slush grout application in an open, cleaned joint.**

Slush grout is a neat cement grout (for cracks less than ½ inch) or a sand-cement slurry (for cracks greater than ½ inch) that is placed into cracks in the foundation. Cracks or joints are filled with grout rather than spreading grout on the surface (as shown in figure 3.2.6.4-1). Slush grout should be used to fill narrow surface cracks and not to cover areas of the foundation. To ensure adequate penetration of the crack, the maximum particle size in the slush grout mixture should be no greater than one-third the crack width. The consistency of the slush grout mix may vary from a very thin mix to mortar as required to penetrate the crack. The water to cement ratio should be kept as low as possible to prevent shrinkage. The grout preferably should be mixed with a mechanical or centrifugal mixer, and the grout should be used within 30 minutes after mixing.

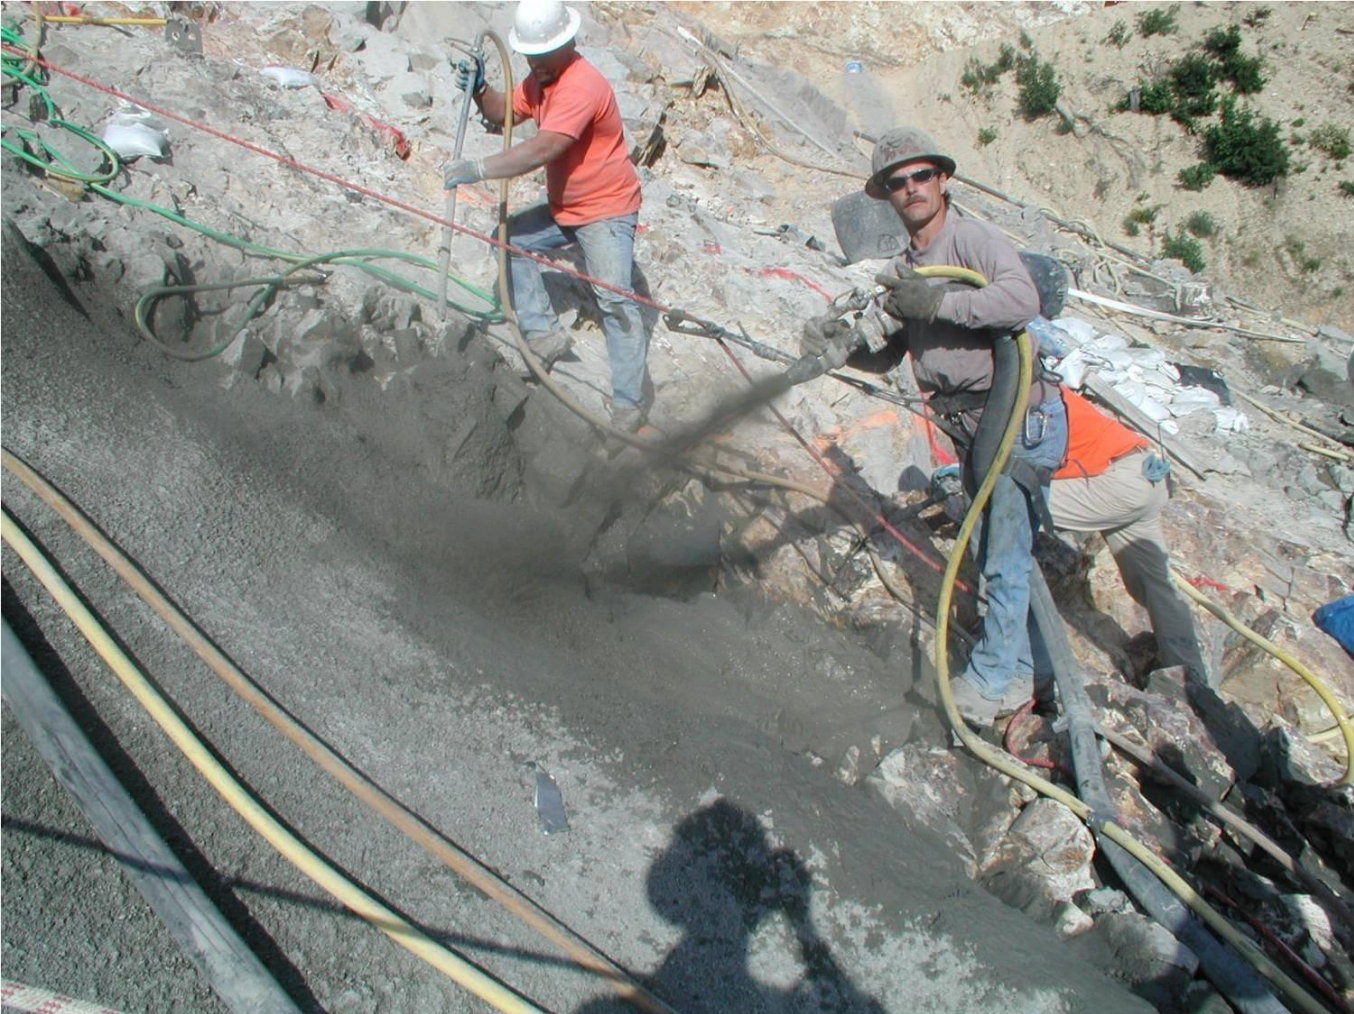
Figure 3.2.6.5-1 Shotcrete application.

Shotcrete is concrete or mortar that is sprayed in place. Some shotcrete is mixed with synthetic fibers to obtain a stronger product and so it can adhere to steeper slopes. The quality of the shotcrete depends on the skill and experience of the crew, particularly regarding the amount of rebound, thickness, feather edges, and ensuring adequate thickness over protrusions on irregular surfaces. Shotcrete should be placed in thin lifts (2 inches or less) to ensure intimate contact with the foundation rock. Areas that have not yet been prepared can be inadvertently covered because of the ease and rapidity of placement. Shotcrete should be used beneath impervious zones only when site conditions preclude using dental concrete. If shotcrete is used, close inspection and caution are necessary. Shotcrete can be an acceptable alternative to dental concrete outside the core contact area (figure 3.2.6.5-1).

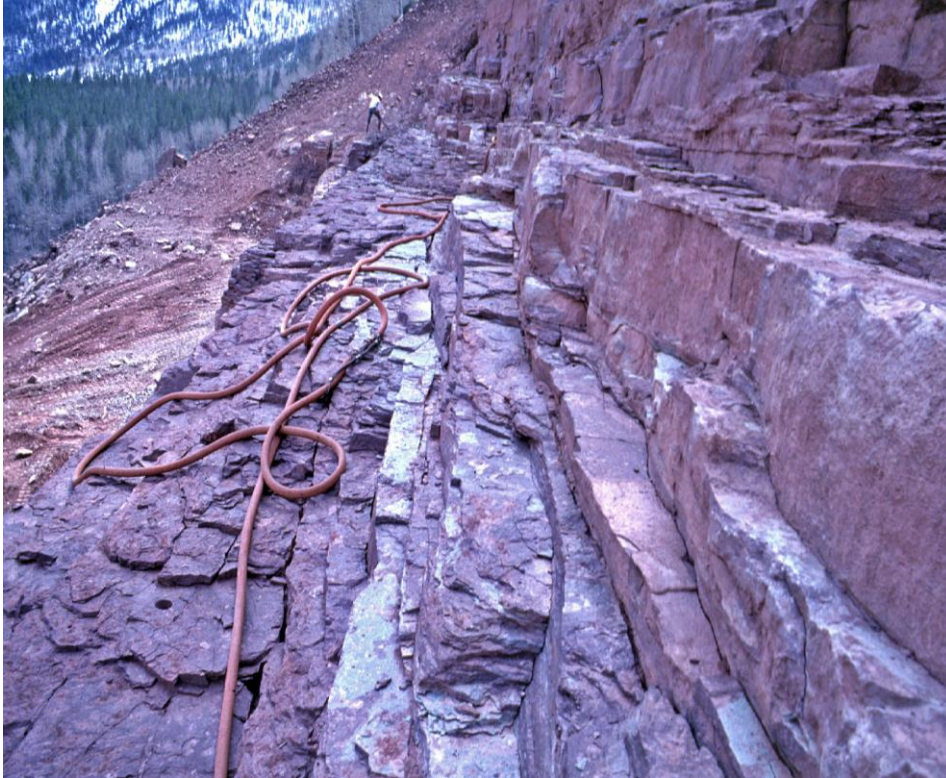
**Figure 3.2.6.6-1 Upper Stillwater Dam. Foundation excavated to material capable of withstanding loads imposed by the dam. Left side of photograph shows acceptable steps; right side shows steps requiring concrete fillets.**

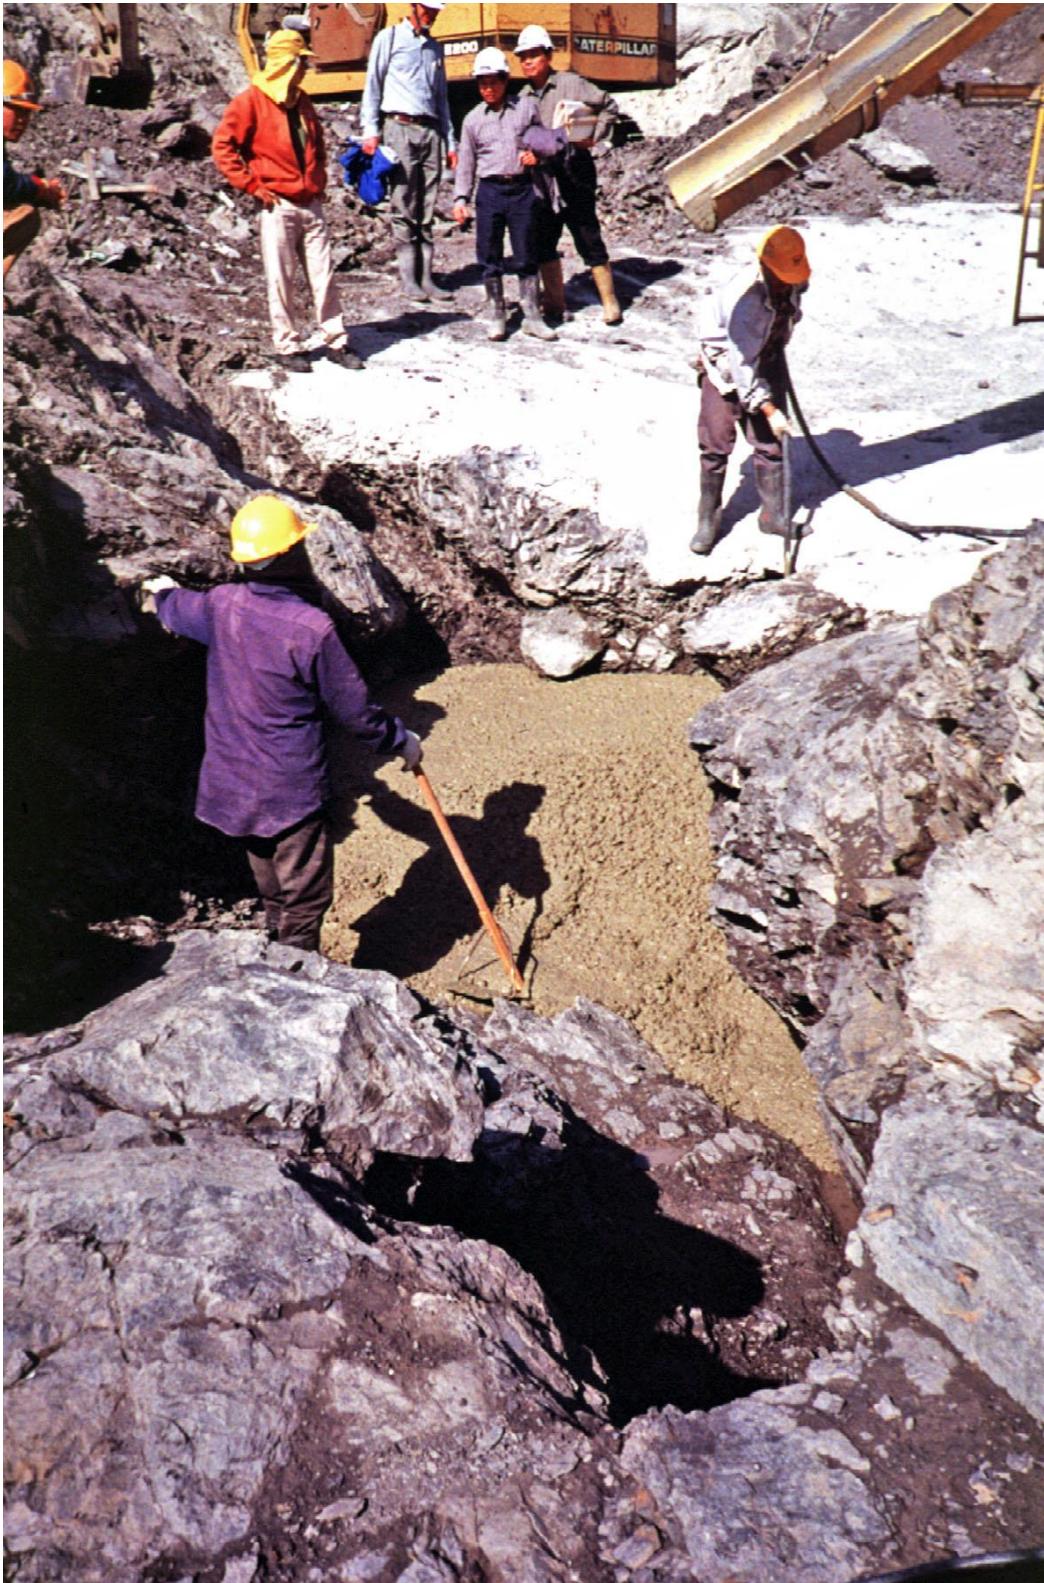
Figure 3.2.6.6-2 Treating foundation with dental concrete.

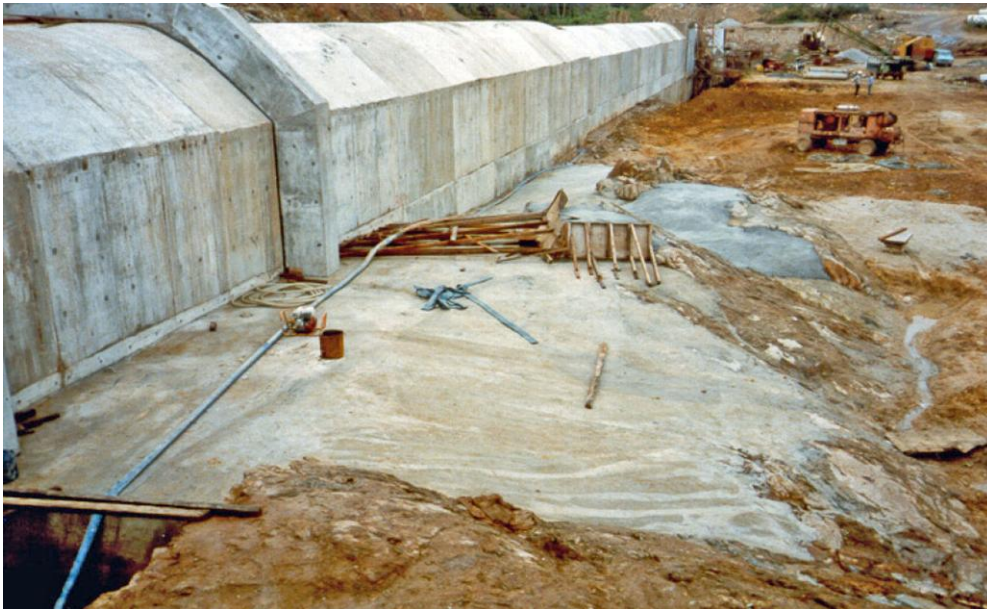
**Figure 3.2.6.6-3 Foundation for outlet works structure was shaped and treated with dental concrete.**

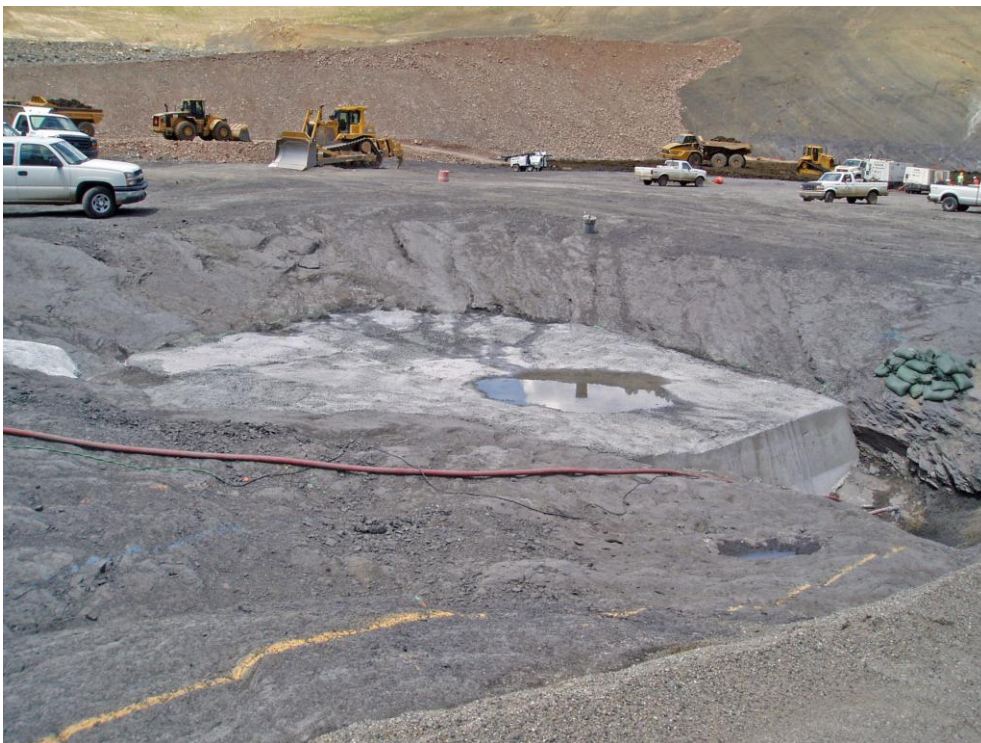
**Figure 3.2.6.6-4 Ridges Basin Dam. Foundation dental concrete. Sometimes a dental concrete slab is a mass placement.**

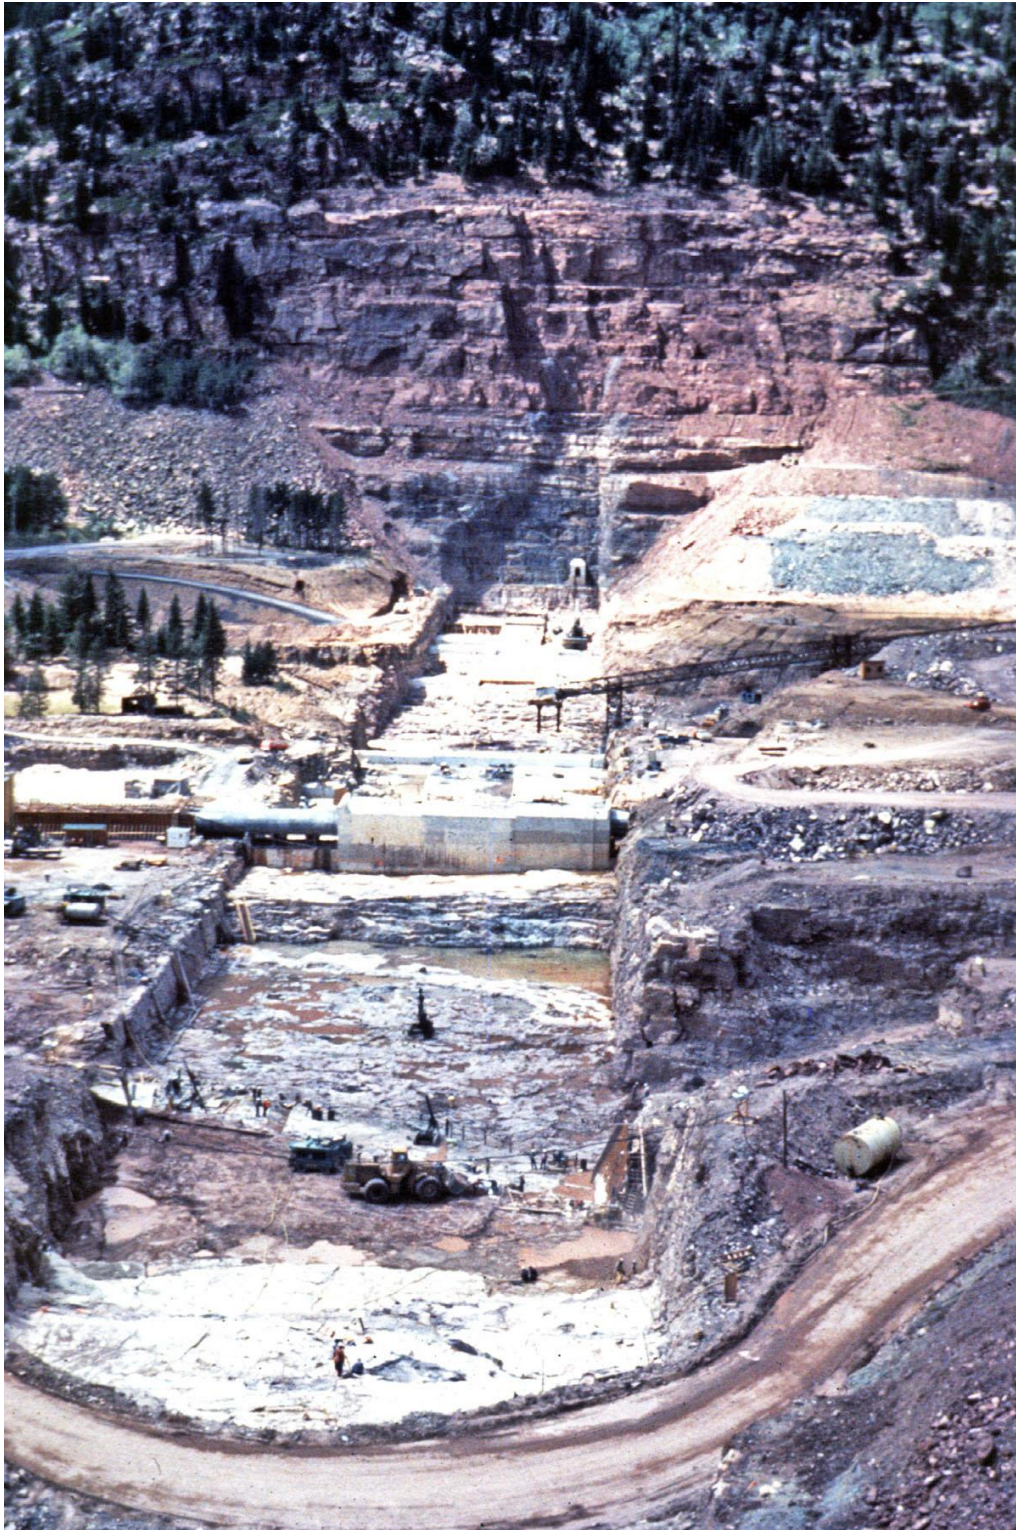
**Figure 3.2.6.6-5** Entire footprint of a concrete gravity dam is excavated to material capable of withstanding loads imposed by the dam.

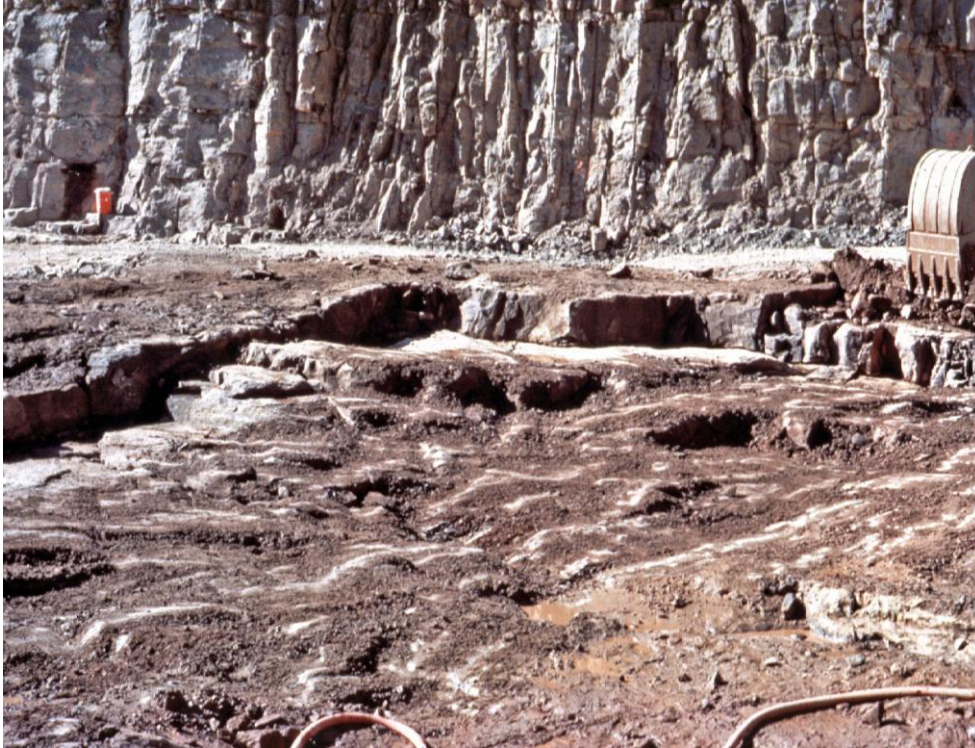
Figure 3.2.6.6-6 Upper Stillwater Dam. After stripping and before cleanup.
