**Design Standards No. 13**

## **Embankment Dams**

**Chapter 3: Foundation Surface Treatment  
Phase 4 (Final)**

**DS-13(3)-2: Phase 4 (Final)**  
**July 2012**

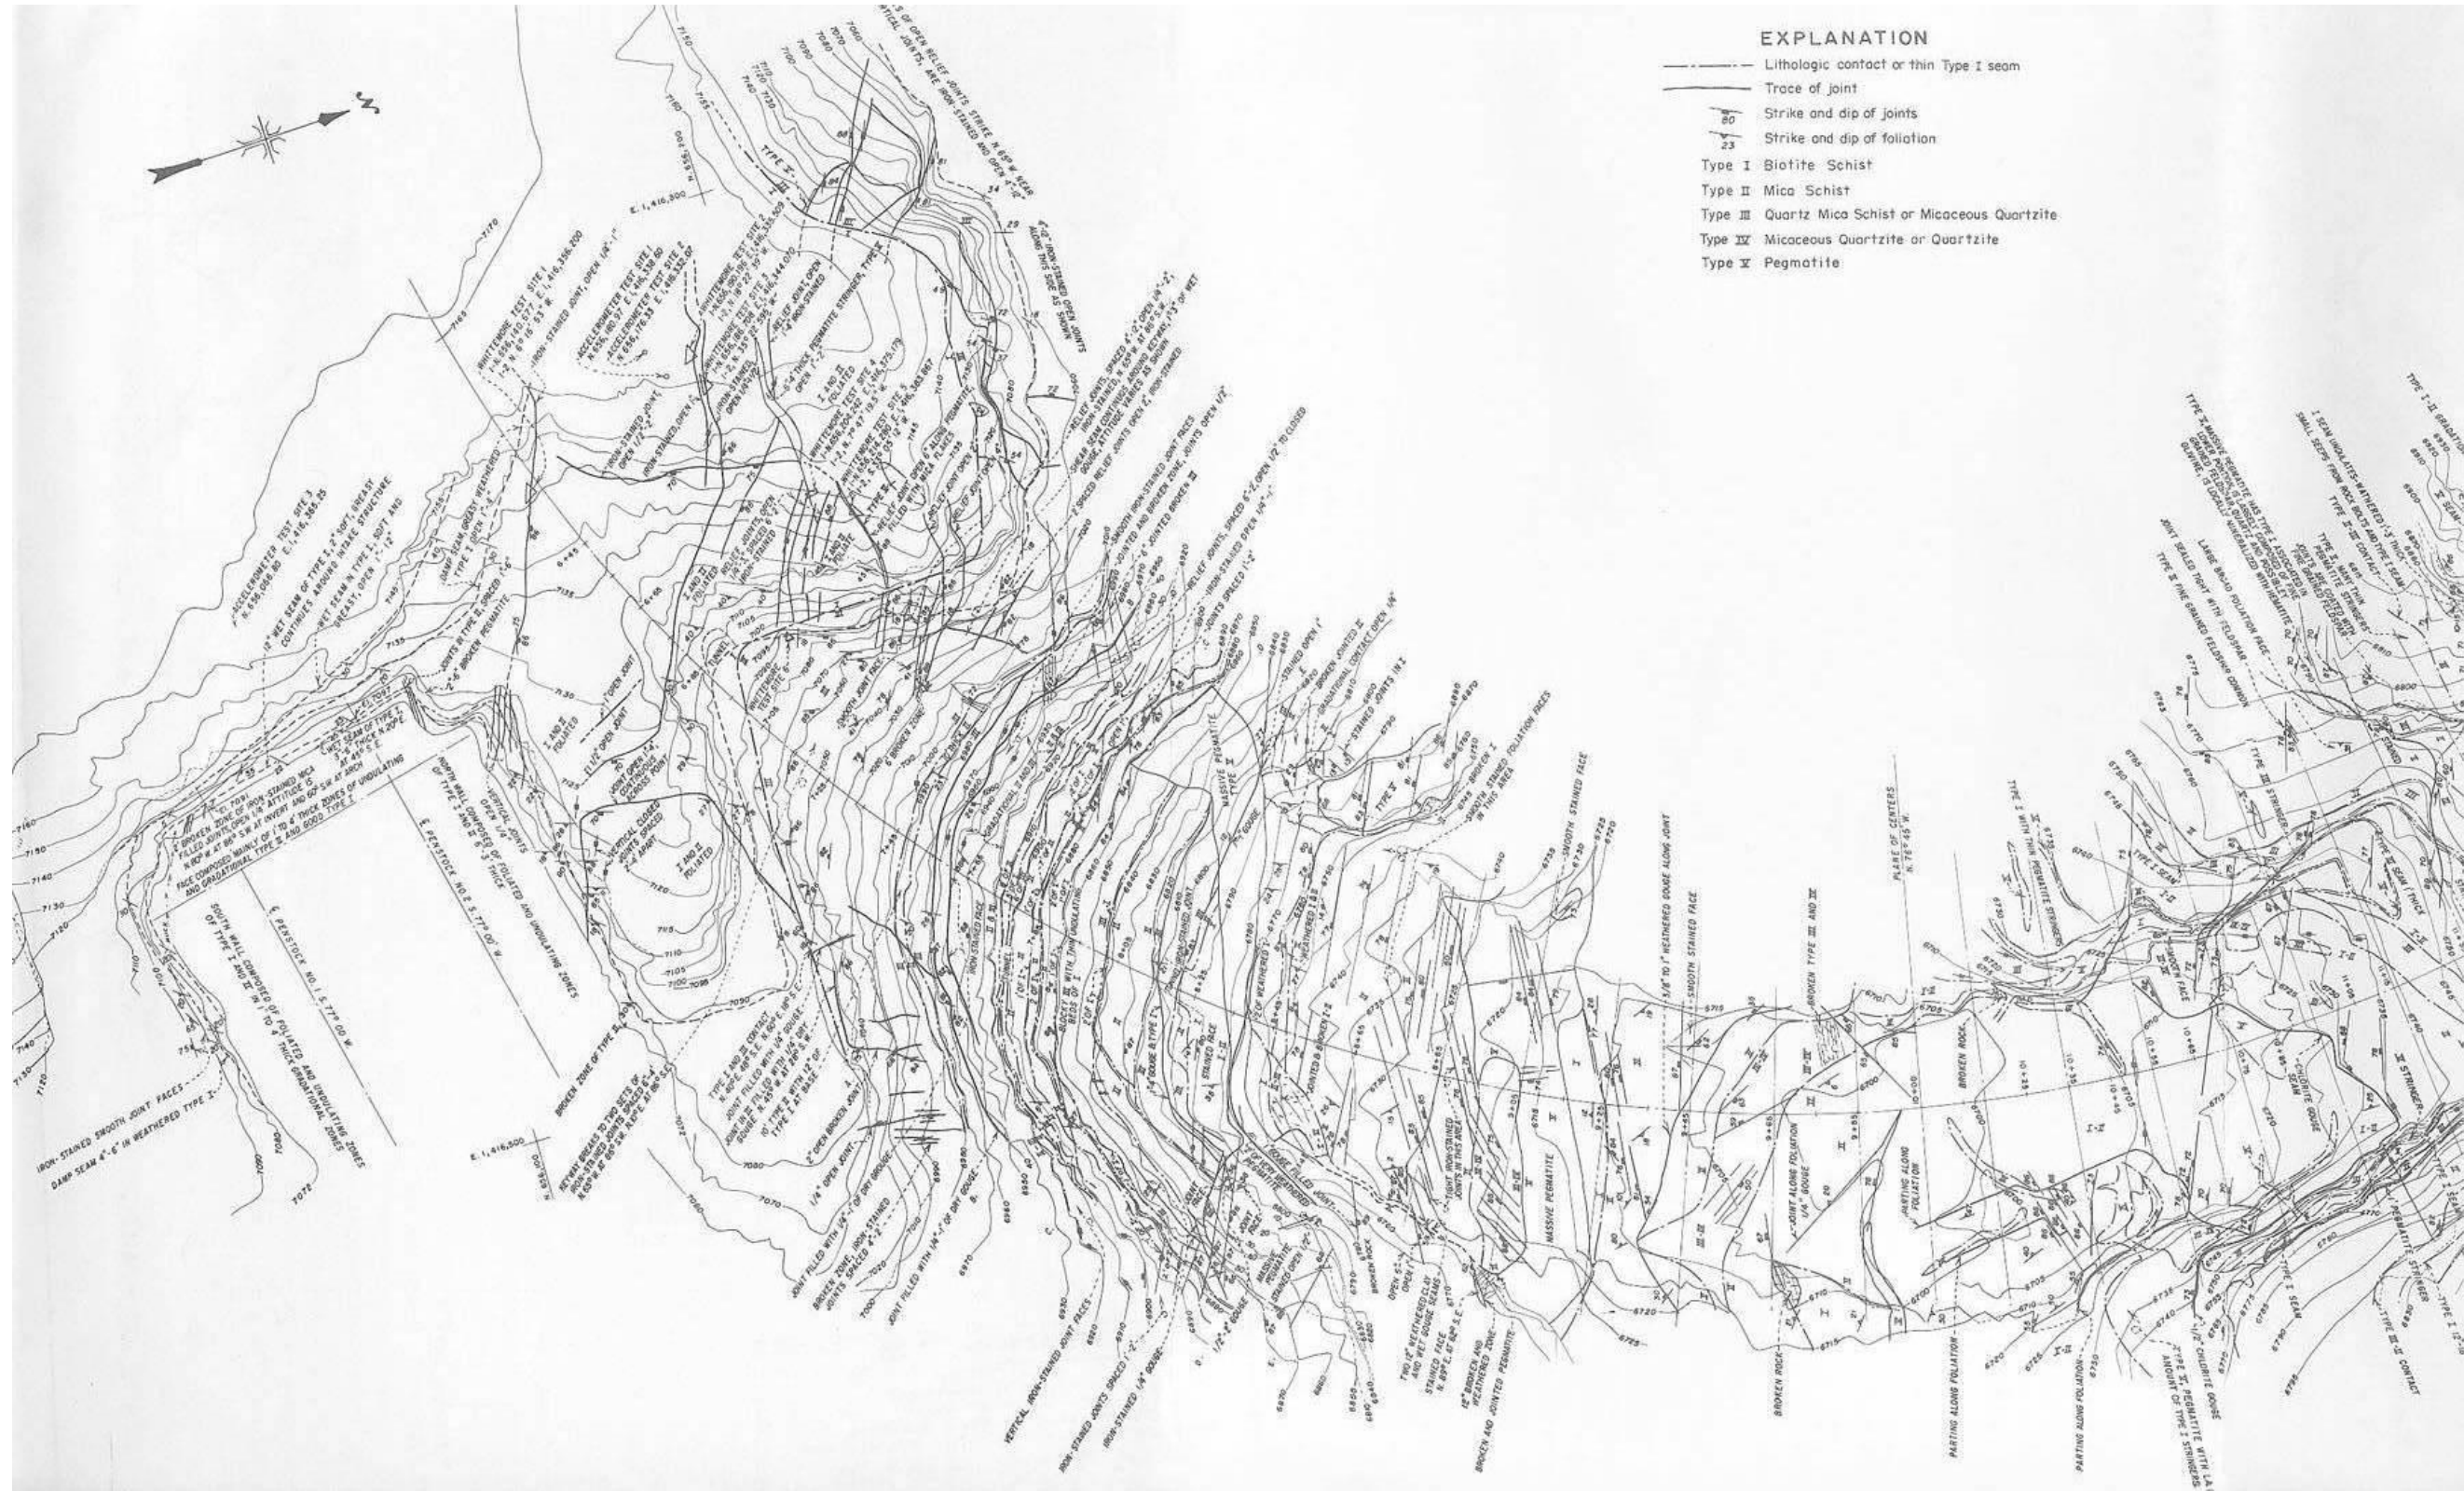
Figure 3.3-2 Typical detail of geologic foundation map.

Figures 3.3.1 and 3.3.2 illustrate geologic mapping and photographic methods to document foundation conditions.

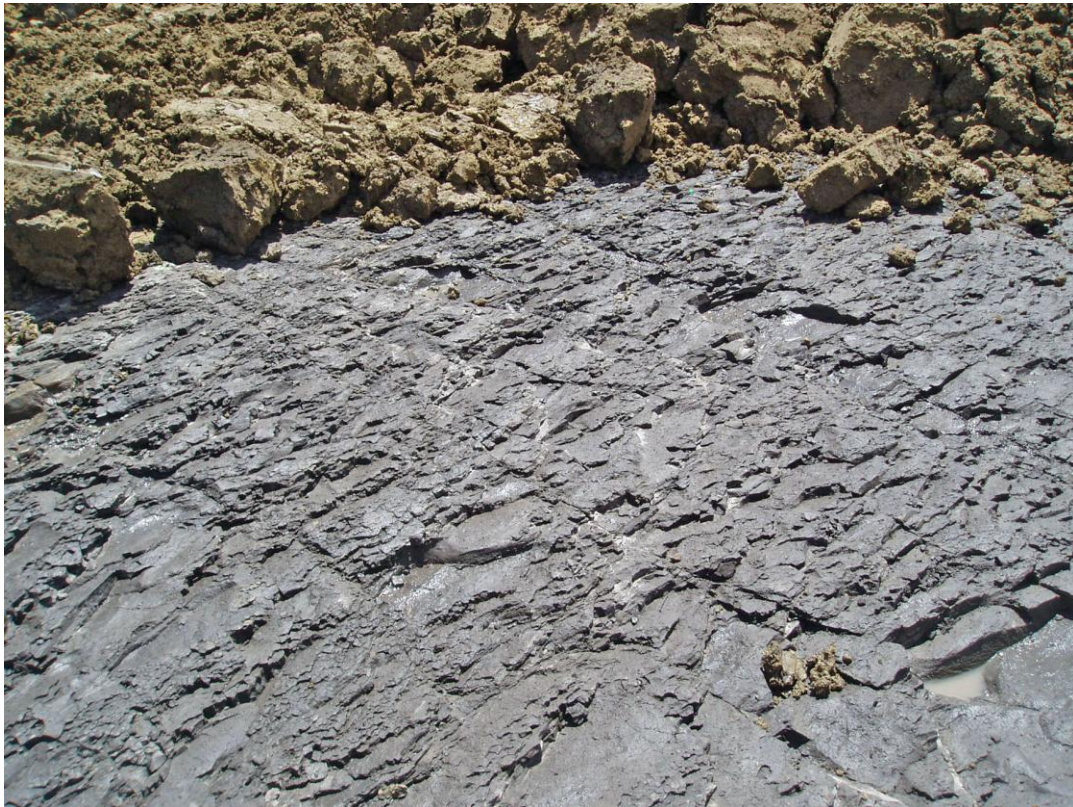
**Figure 3.4.2-1 After final cleanup, the foundation is moistened prior to placing and compacting embankment fill.**

Rock foundation surfaces should be moistened, but no standing water should be permitted when the first lift is placed. The foundation should be properly moistened to prevent drying of the soil as shown in figure 3.4.2-1. The moisture content of impervious embankment material should be between 0 and 2 percent wet of optimum moisture content, and the maximum particle size is 1 to 2 inches. When the availability of plastic material is limited, it is common practice to select and use the more plastic material at the foundation contact. Because of the high plasticity of these lifts, they are vulnerable to desiccation if allowed to dry too much. Lifts that have been allowed to desiccate shall be removed entirely. On steep, irregular rock abutments, material slightly wetter than optimum may be necessary to obtain good workability and a suitable bond. When using special compaction, be careful to ensure that suitable bonds are created between successive layers of material. This usually requires light scarification between lifts of compacted material. Special compaction methods, such as hand tamping, should be used in pockets that cannot be compacted by roller, such as irregular rock surfaces. However, where foundation surfaces permit, a pneumatic-tire roller or other pneumatic-tire equipment should be used near foundation contact surfaces. An alternative to using thin lifts is using a pneumatic-tire roller or loader with a full bucket (see figures 3.4.2-2 and 3.4.2-3) and disking or

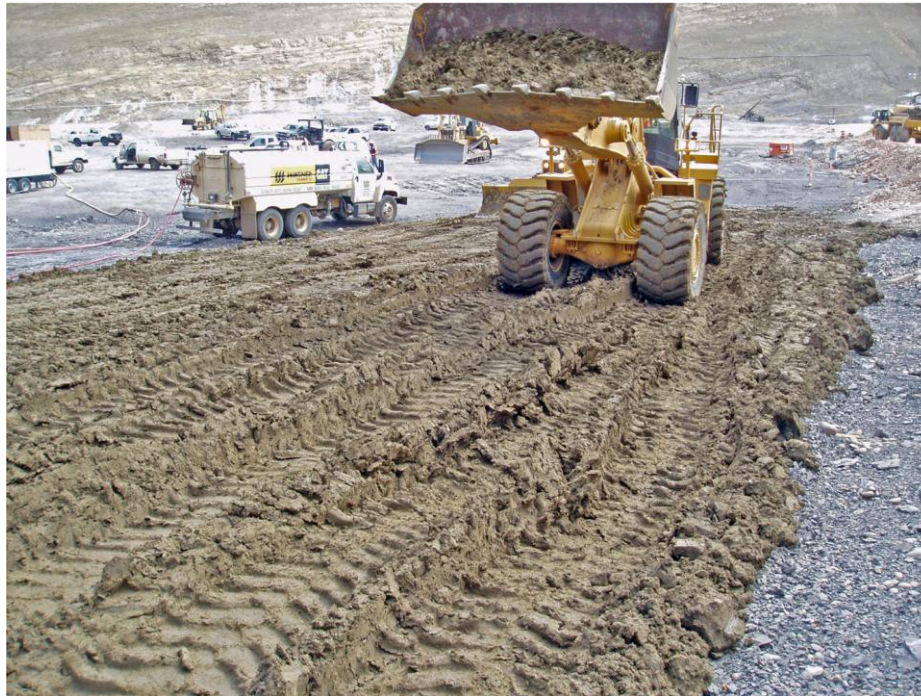
**Figure 3.4.2-2** Pneumatic-tire equipment should be used to compact fill near the foundation contact surfaces. A sheep's foot or tamping roller may be used when the fill is thick enough to prevent contact of the tamping feet with the foundation.

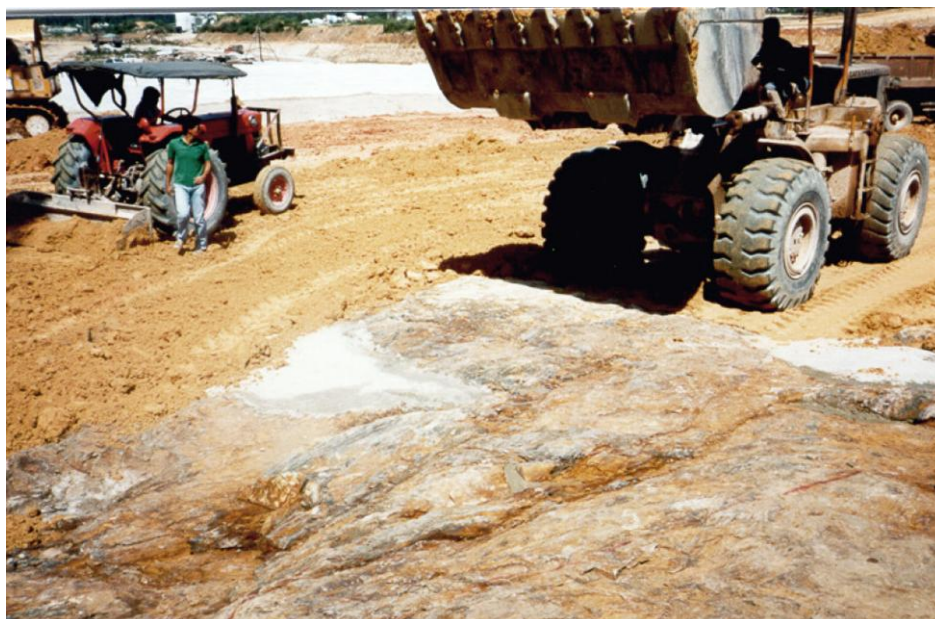
**Figure 3.4.2-3** Pneumatic-tire equipment forces the plastic and deformable earthfill into all remaining uneven surfaces in the foundation surface and may create a feather edge at the ends of the placement.

Earthfill placed against remaining, small, uneven surfaces should be plastic and deformable so that the material is forced (squeezed) into all irregularities on the foundation surface by compaction or subsequent loading as shown in figure 3.4.2-3. The soil moisture content at the first layer should range from 0 to 2 percent wet of optimum. Select material with a required plasticity range is commonly specified. A soil plasticity index ranging from 16 to 30 is preferred

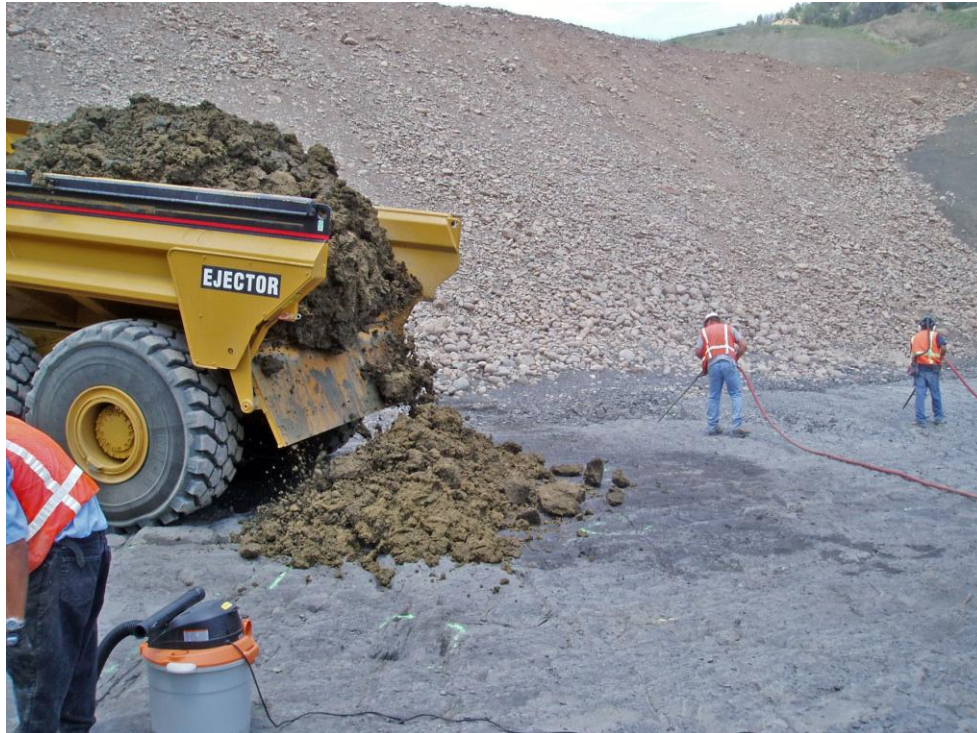
Figure 3.4.2-4 Ridges Basin Dam. Final foundation cleanup and placing the first lift of embankment fill.

scarifying the lift surfaces to obtain a bond between lifts. The tamping roller can be used when the fill is sufficiently thick and regular to protect the foundation from the tamping feet. Unit weight and moisture should be carefully monitored in the foundation contact zone, and placing and compacting operations should be carefully inspected. For an illustration of the process of placing embankment fill on a rock foundation, see figures 3.4.2-4 through 3.4.2-6.

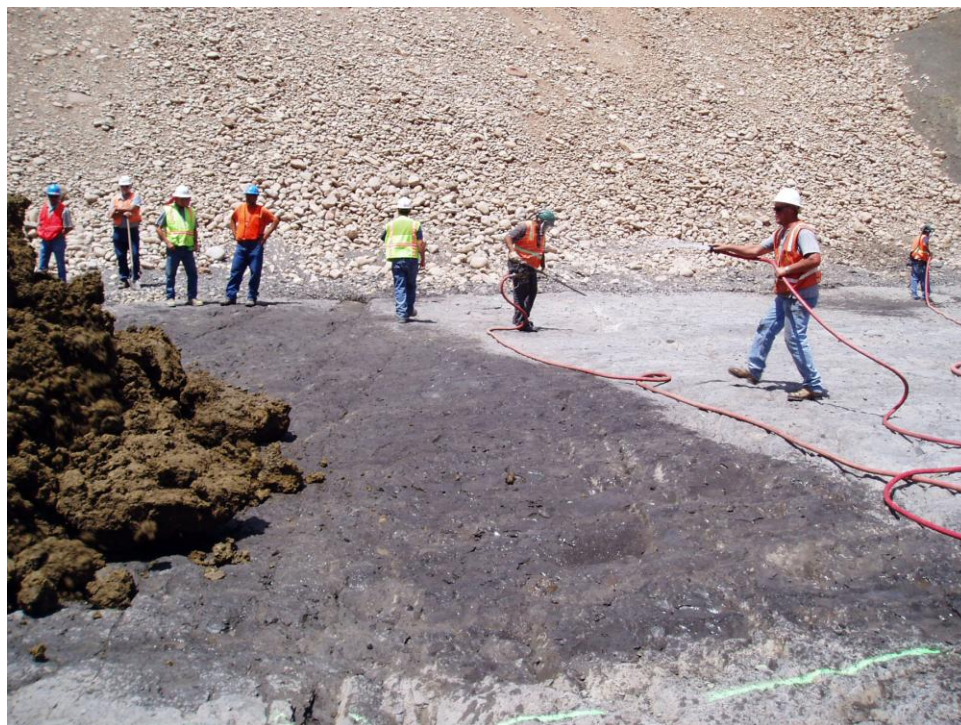
Figure 3.4.2-5 Ridges Basin Dam. Final foundation cleanup, wetting, and placing first lift.

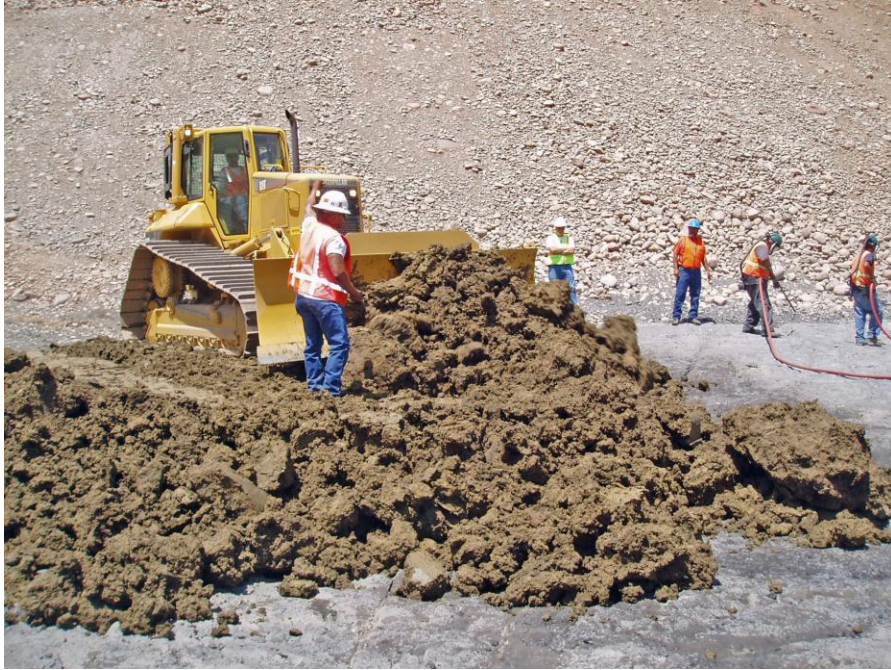
**Figure 3.4.2-6 Ridges Basin Dam. Final foundation cleanup and spreading first lift. Note the dozer is working on the fill, not on the foundation surface, to prevent foundation damage. Foundation rock in foreground has been moistened.**

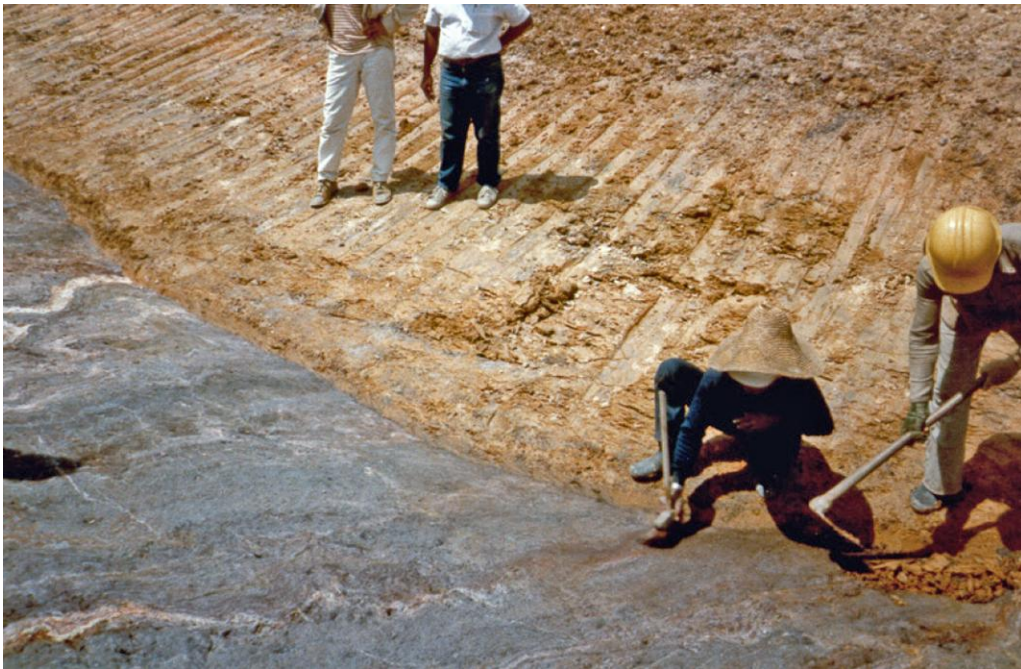
**Figure 3.4.2-7 Feather edge of first lift of compacted fill removed, cleaned, and ready for fill placement.**

although not absolutely necessary. Feathered edges of compacted fill should be removed prior to subsequent placements as shown in figure 3.4.2-7.

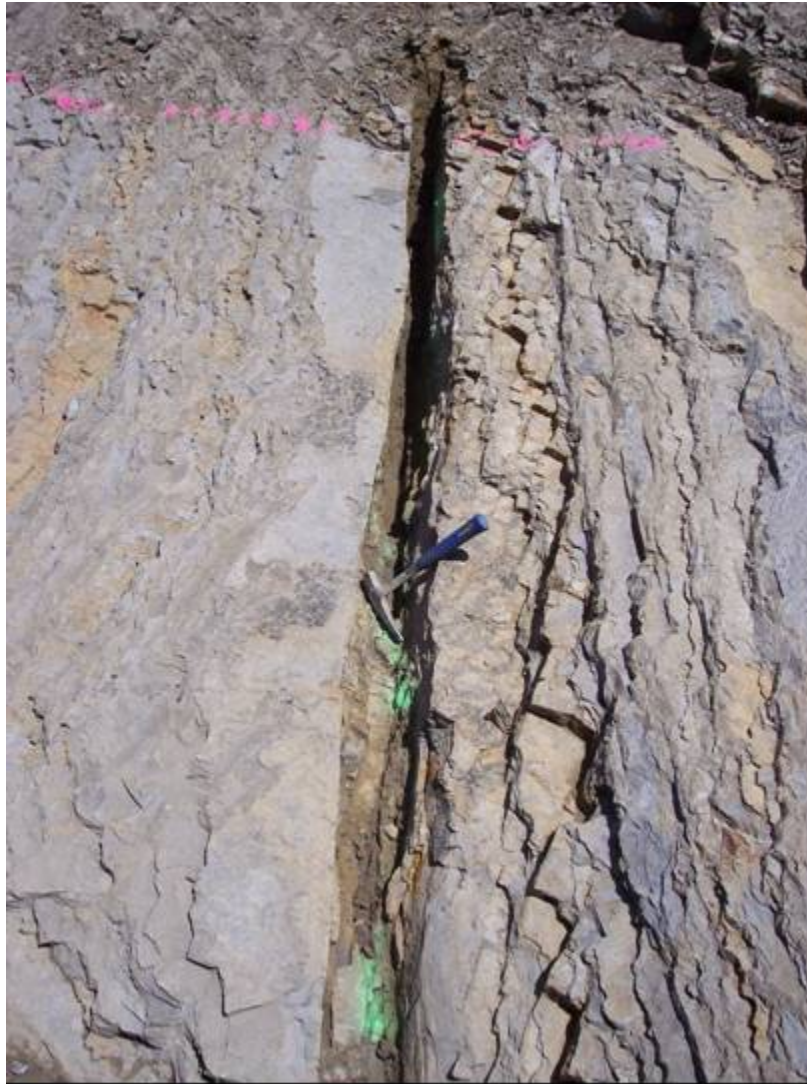
**Photograph 1.** Weathered rock materials have been excavated from an "A" joint on the left abutment at approximate Station 22+58, 132' US in preparation for slush grouting. The weathered materials have become firm throughout most of the exposed joint at the excavated depth.  
May 23, 2006 (Photo by J. Gates) Reference Image Only

Final cleanup on the left abutment was performed in strips (roughly 5 feet in elevation) extending upstream to downstream along the lower portions of the abutments. The foundation in this area consists of the Lewis Shale. Several "A" joints trending approximately N20-30W are exposed in this area of the foundation. The joints are predominantly tight to slightly open to 1/16-inch but occasionally contain weathered siltstone to a width of 1- to 2-inches. Where this material is weathered and soft, it is removed by either compressed air or rock pick to a depth of three times the width and the opening is slush grouted immediately prior to placement of Zone 1. The removal of this material often creates an opening with a depth of 1- to 4-inches and the material generally becomes firm and the joint tightens with depth. The slush grout is a cement/sand/water mixture which is mixed thin enough to penetrate the joint being treated.

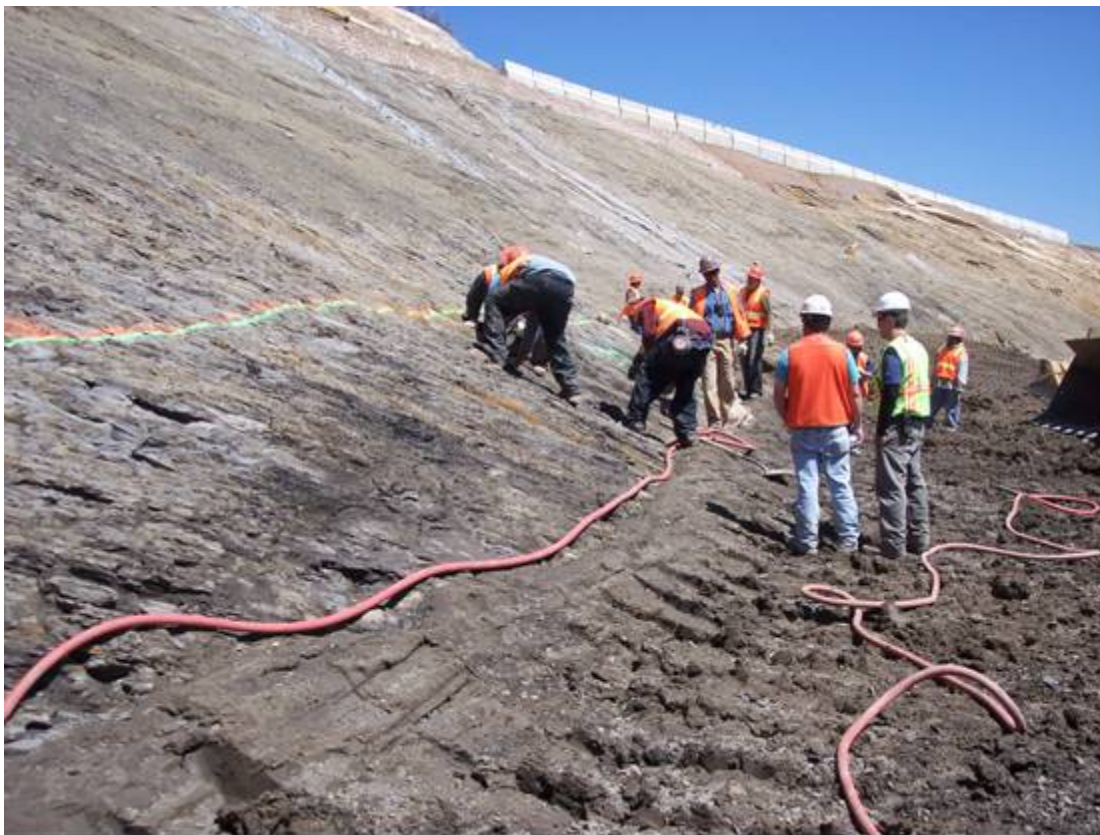
**Photograph 2. Crew finishes preparing the foundation for Zone 1 placement on the lower left abutment at approximate Station 22+30, 150' US. View looking downstream. May 5, 2006 (photo by R. Christianson)**

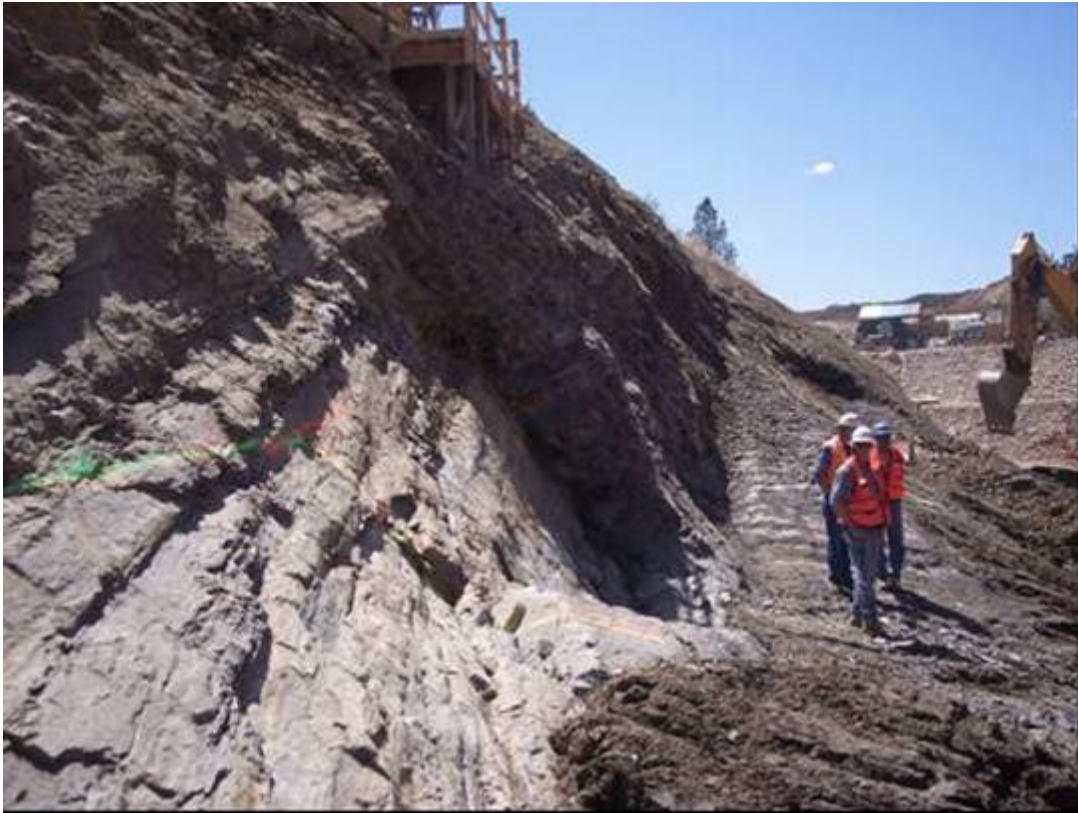
**Photograph 3. Upstream view of fractured rock prior to additional excavation taking place above approximate elevation 6665 on the upstream right abutment. Geologist and inspectors are standing at approximate Station 14+55, 135' upstream of centerline. April 27, 2006 (Photo R. Christianson)**

A Caterpillar 365 excavator has been used to excavate weathered and fractured rock along the right abutment between approximate Stations 14+60, 125' US and 14+10, 215' US. The fractured rock was originally identified during geologic mapping in June 2005 as requiring removal prior to placement of dam embankment. The fractured rock is adjacent to a clay filled joint trending upstream/downstream along the right abutment. The joint was identified during geologic mapping as JR234 (N84W, 68NE) and is representative of the "C" Joint set. Joint JR 244, also mapped in this area, was similar in nature and indicated that additional excavation was necessary. The decision was made at that time to leave the material in place during the foundation grouting operation and remove it as the embankment was brought up. There was no additional excavation until late April 2006, when initial scraping for final cleanup was performed with a Caterpillar 325 excavator equipped with a butterbar, revealing a significant, clay-filled (up to 2-inches) joint. Attempts at removing the intensely fractured rock overlying the joint using the 325 excavator were unsuccessful. The 365 track-hoe was mobilized to excavate the rock mass on May 1<sup>st</sup>, 2006 and again May 9<sup>th</sup> and 10<sup>th</sup>, 2006.

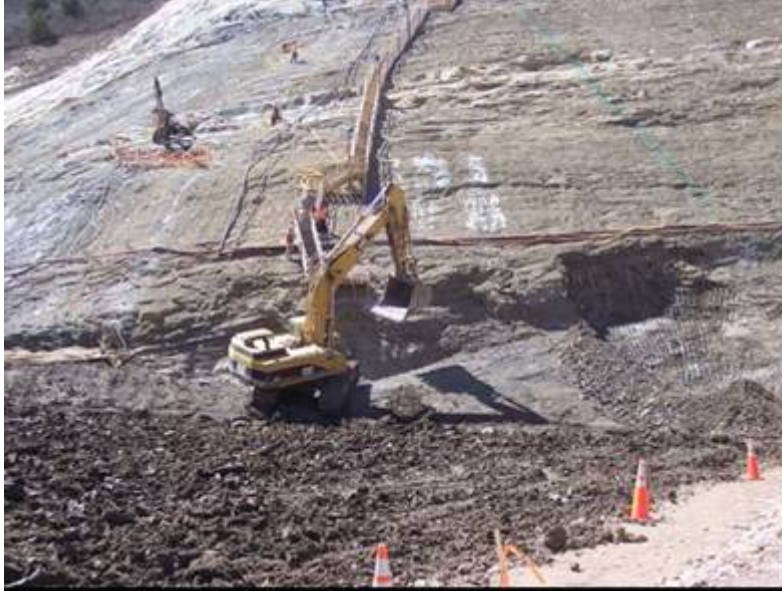
**Photograph 4. Caterpillar 365 excavator beginning the additional excavation on the right abutment to remove fractured Lewis Shale.  
May 1, 2006 (Photo by J. Gates)**

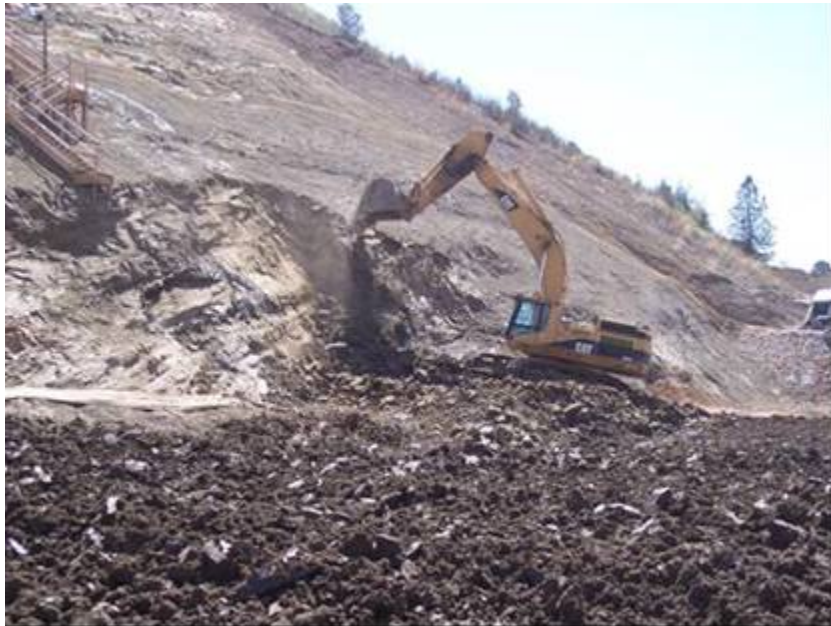
**Photograph 5. Additional excavation is being accomplished using a Caterpillar 365 trackhoe and is exposing a prominent joint face on the upstream right abutment. The excavator can be seen working on the upstream transition.  
May 10, 2006 (Photo by J. Gates)**

The additional excavation has resulted in the exposure of a joint face along the abutment. The joint strikes from N88W to N65E, and dips toward the valley at 51 to 68 degrees. Dental concrete was used along the upstream portion of the joint face where it intersects bedding.

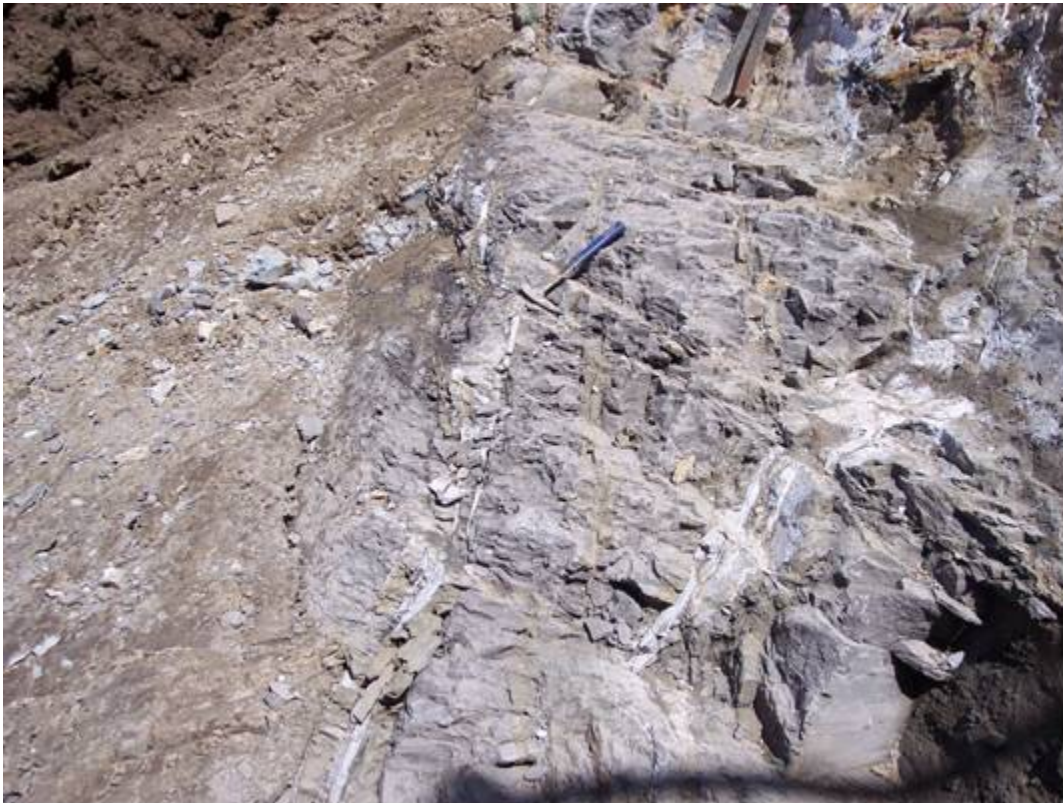
**Photograph 6. Joint on right abutment near Station 14+55, 130' US that is filled with grout from foundation pressure grouting operations. The grout reaches a maximum thickness of about 3/4 inch. Grout can also be seen along a joint at the upper right of photo. View looking downstream. April 27, 2006 (Photo by R. Christianson) Reference Image Only**

Stress relief “exfoliation” joints are common within a section of the Lewis Shale which is approximately 20 to 40 feet below the contact of the overlying Pictured Cliffs Sandstone and is most prevalent along the lower portion of the grouting stairway. The jointed rock has locally required additional excavation of up to about 4- to 6-feet. The joints roughly parallel the excavated slope trending N60E to N80E, dipping about 50 to 60 degrees toward the north with spacings ranging from 0.2 to 1.5 feet. The joints are predominantly tight to slightly open to about 1/16<sup>th</sup> inch with an occasional clay filling. Minor groundwater seepage of less than 1/2 gpm appears along the exposed joint traces near Station 15+50, 50’ upstream of dam centerline. Grout from the foundation grouting program is often seen penetrating the joints in thicknesses ranging from about 1/16<sup>th</sup> to 3/4 inch. Exposed joint traces are generally less than 3 feet long and are slush grouted where open.

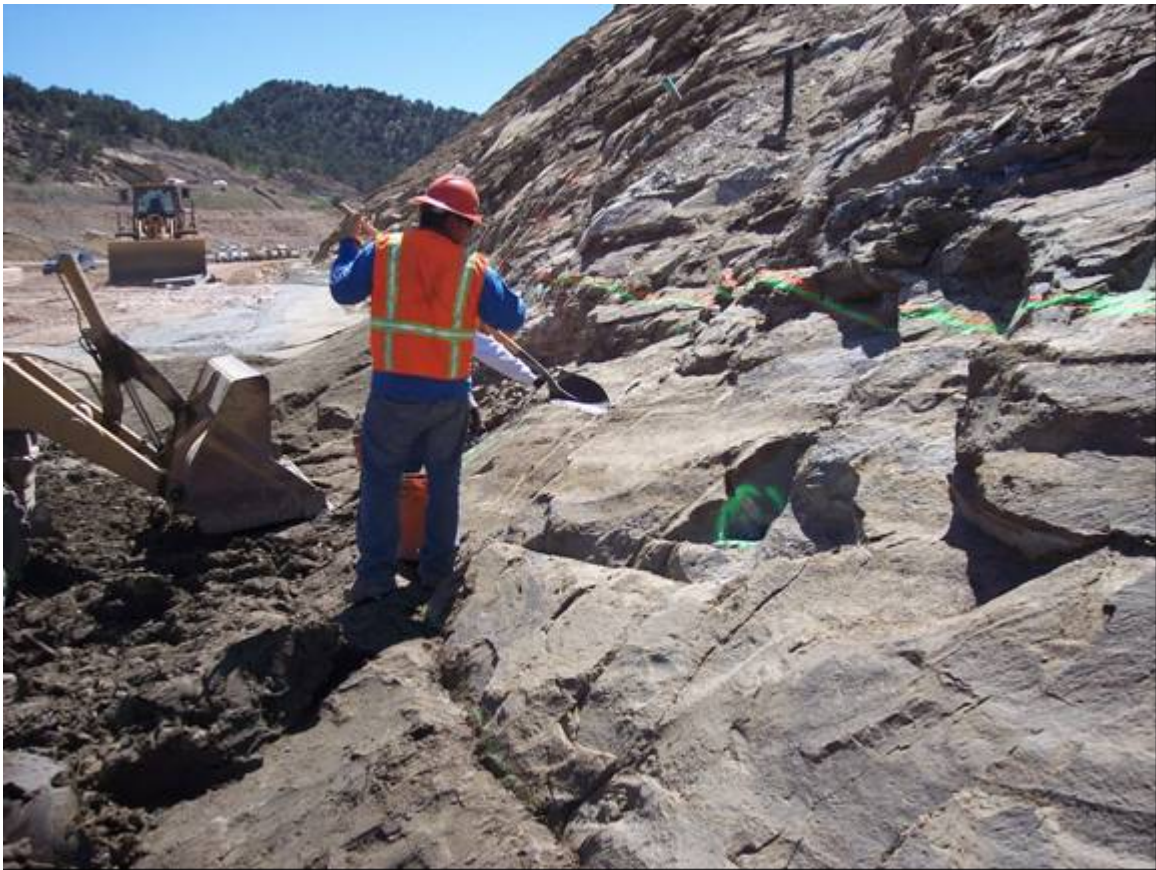
**Photograph 7. Slush grout being placed in preparation for Zone 1 embankment. This area represents the gradational contact between the Lewis Shale and the overlying Pictured Cliffs Unit P1. View looking downstream from approximate Station 15+00 40' U/S. May 24, 2006 (Photo by R. Christianson) Reference Image Only**

Final cleanup in this acceptance area is predominantly within the Lewis Shale with the exception of the extreme downstream Zone 1 footprint near the right abutment ravine area where the Pictured Cliffs is exposed. The upper portions of the Lewis Shale remains classified as a siltstone although it becomes increasingly sandy approaching the contact with the overlying unit P1 of the Pictured Cliffs Sandstone. This gradational contact between the sandy siltstone and the interbedded sandstone, siltstone, and shale, of unit P1 can be seen near the green and orange line in the following photograph.

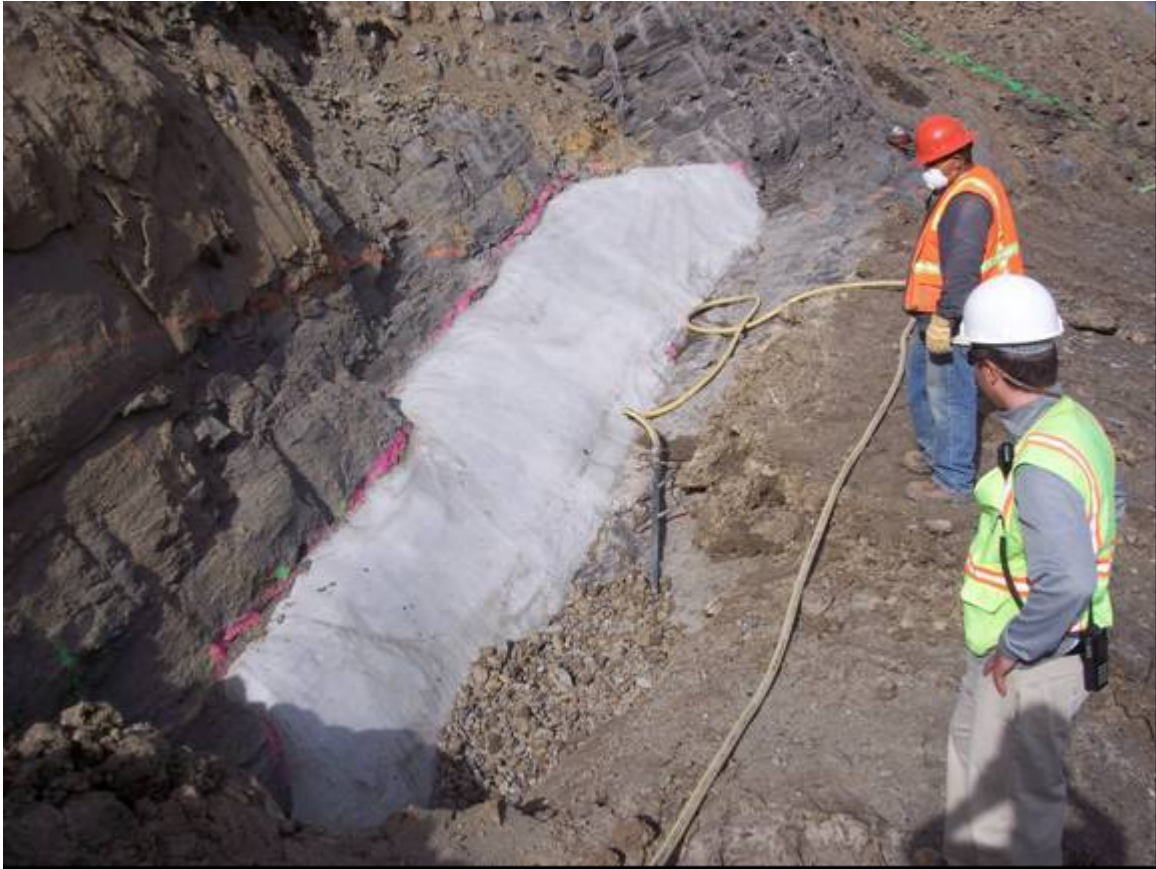
**Photograph 6. Unformed dental concrete at the base of the exposed joint face on the right abutment between approximate Stations 14+15, 168' US and 14+98, 190' US. May 22, 2006 (Photo by J. Gates)**

Slush grout has been required in occasional open joints along the base of the right abutment. Most of the joints are classified within the “C” joint set and trend roughly

N65E, dipping 50-70 degrees northwest toward the valley center. Dental concrete was required in two locations to flatten the slope to less than 0.5:1.
